Static risks from the perspective of a cargo and warehouse surveyor

- less obvious risks -

Battermann & Tillery Global Marine GmbH

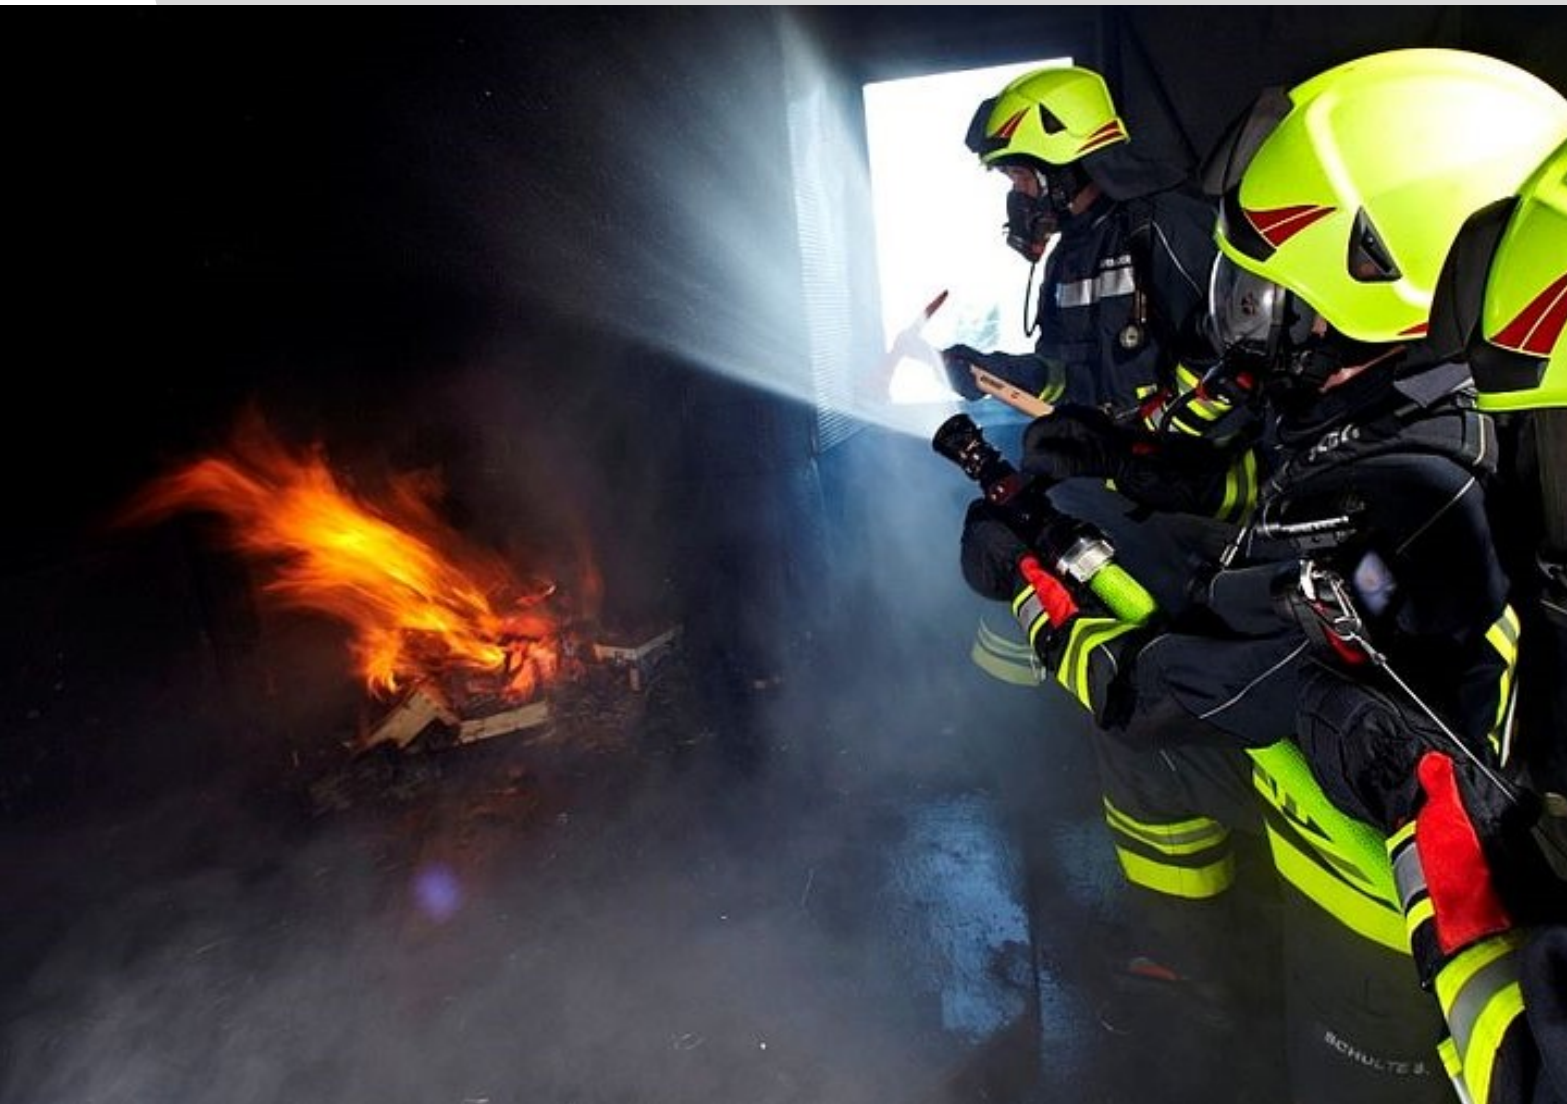
Photo 1: Minor fire

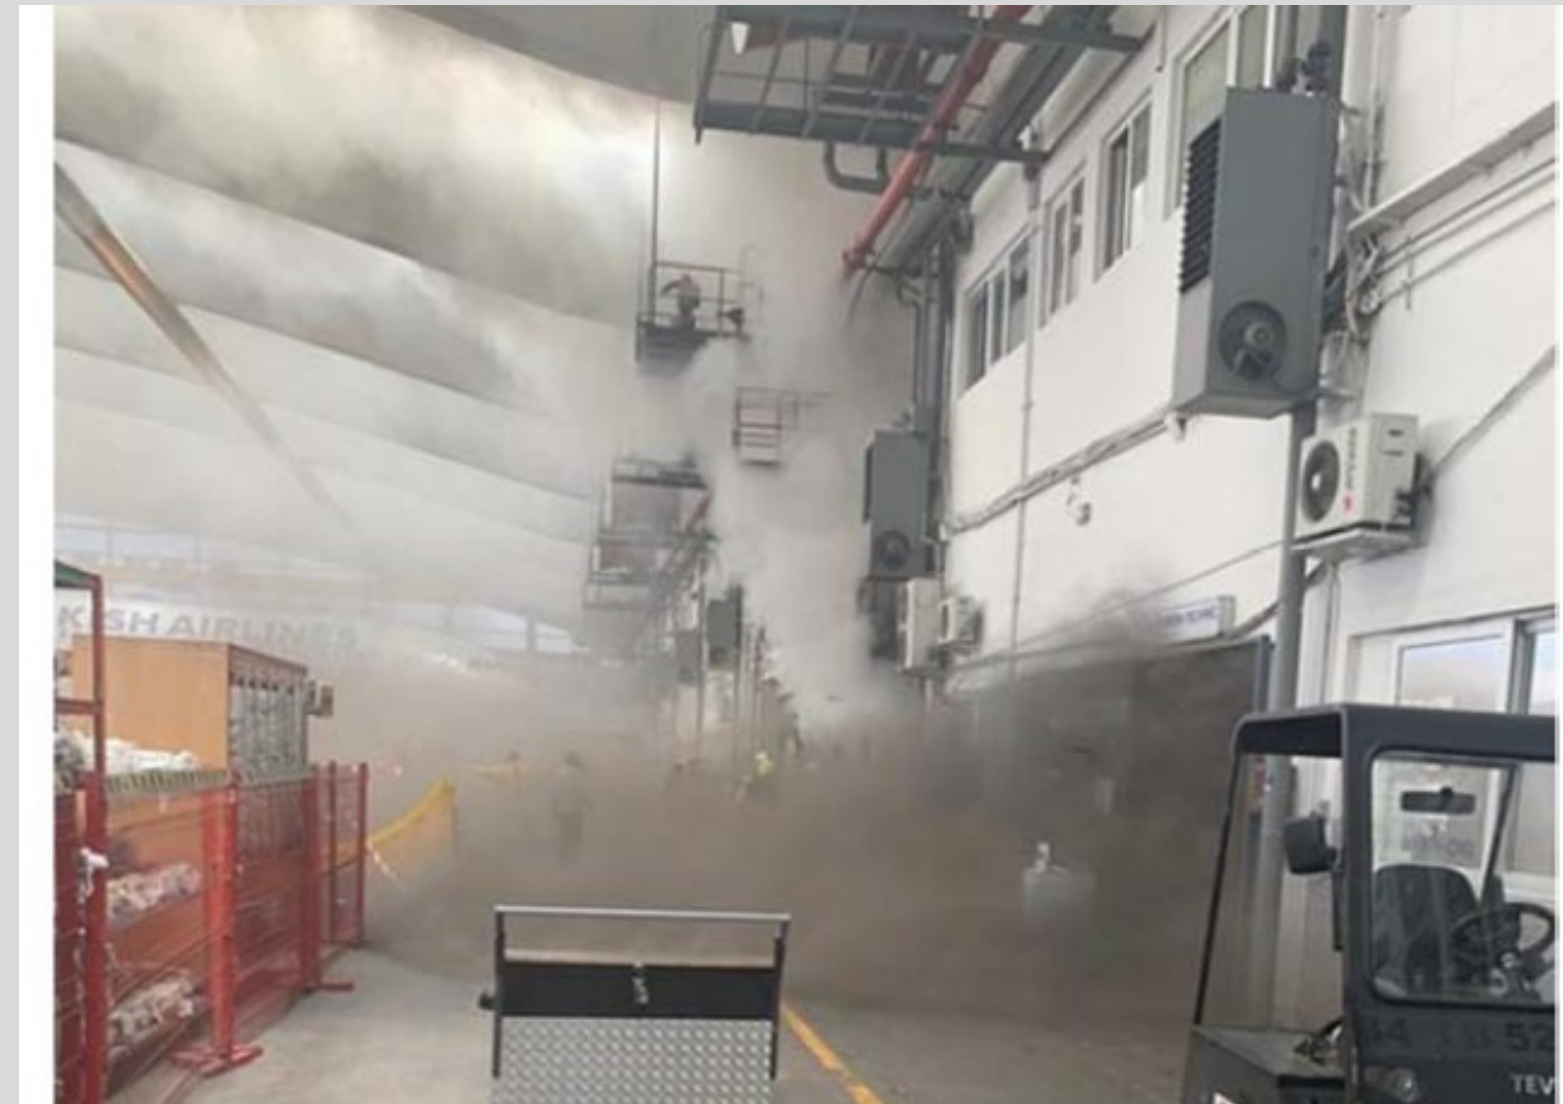
Photo 2: Smoke in warehouse

- Smoke detector triggered
- No sprinklers triggered (yet)
- Fire department underway?
(Sprinkler or smoke detectors?)
- Cargo loss already assumed
- Building damaged already

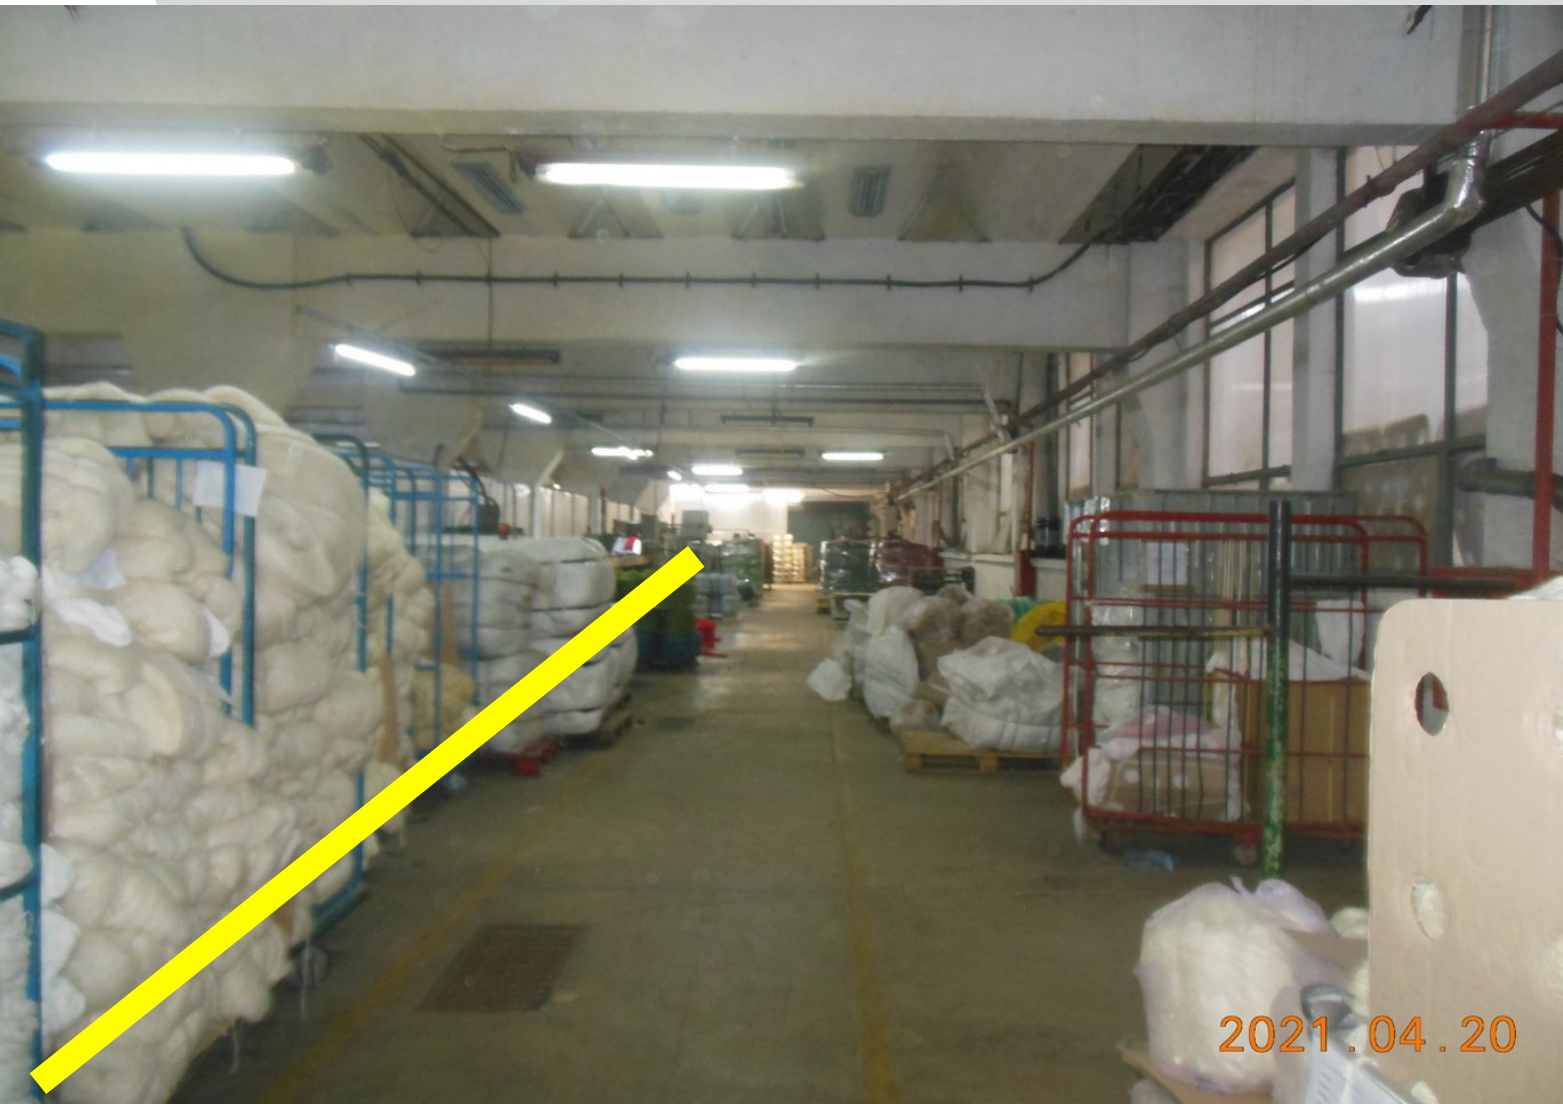
Photo 1: Fire loads in a long row

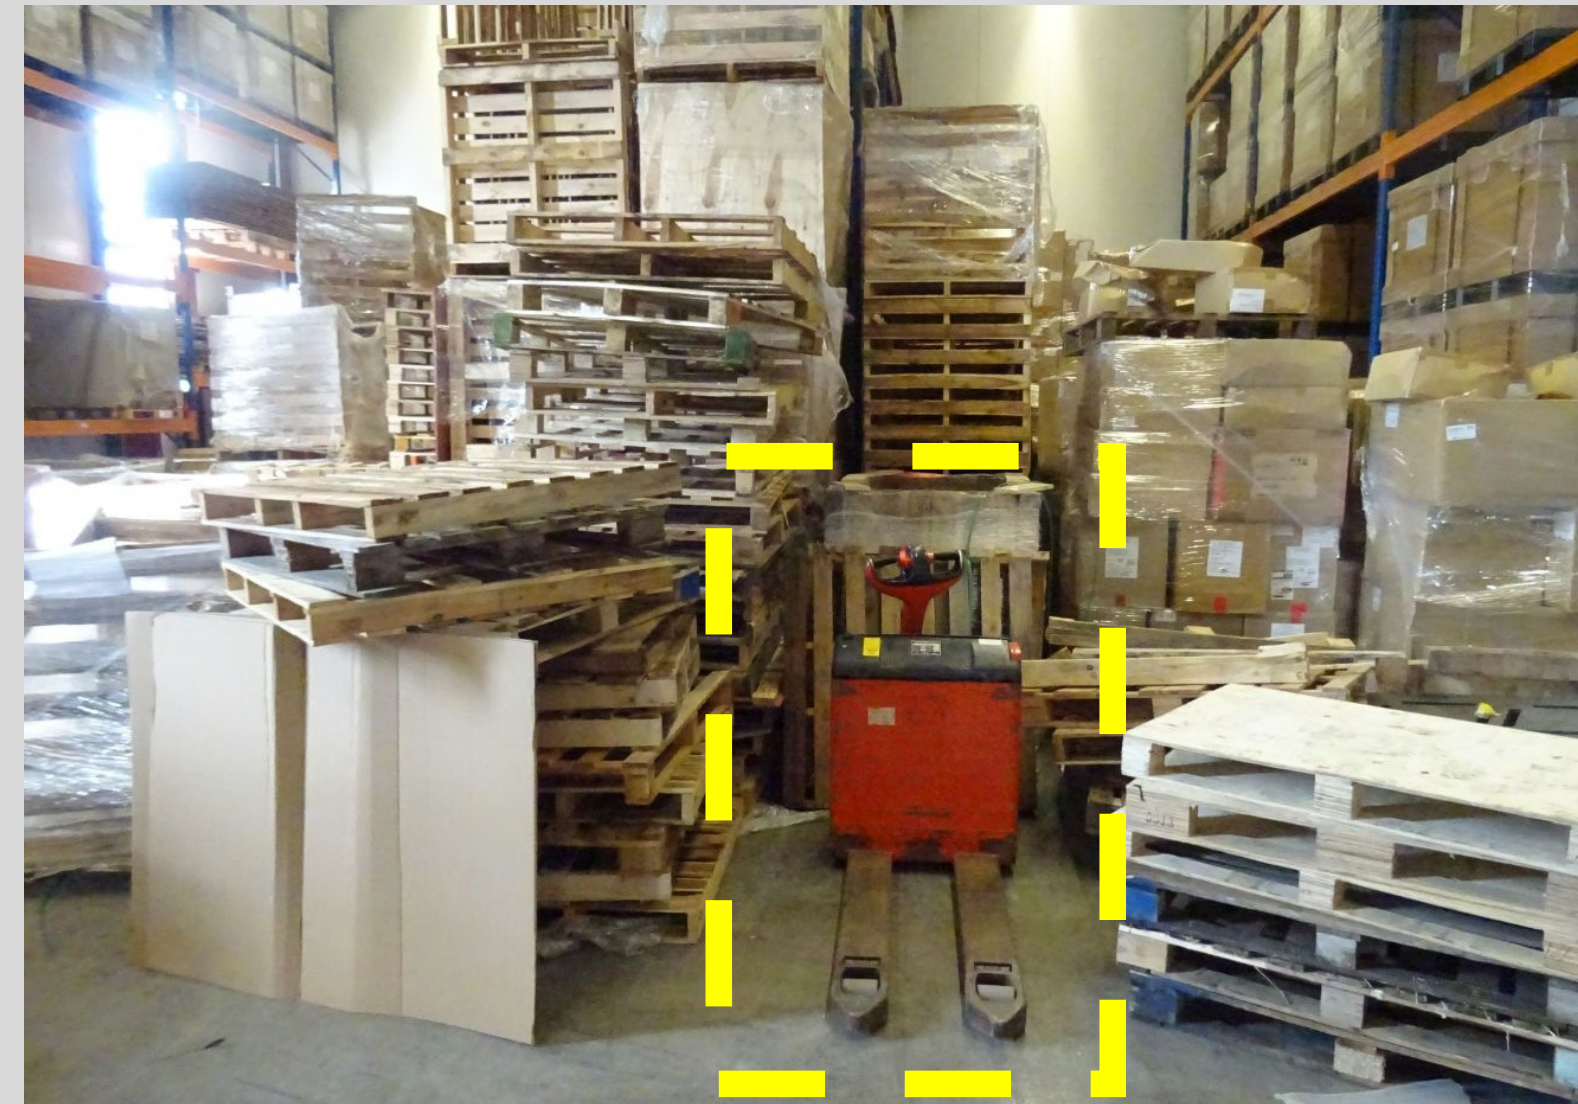
Photo 2: Ignition sources next to avoidable fire loads

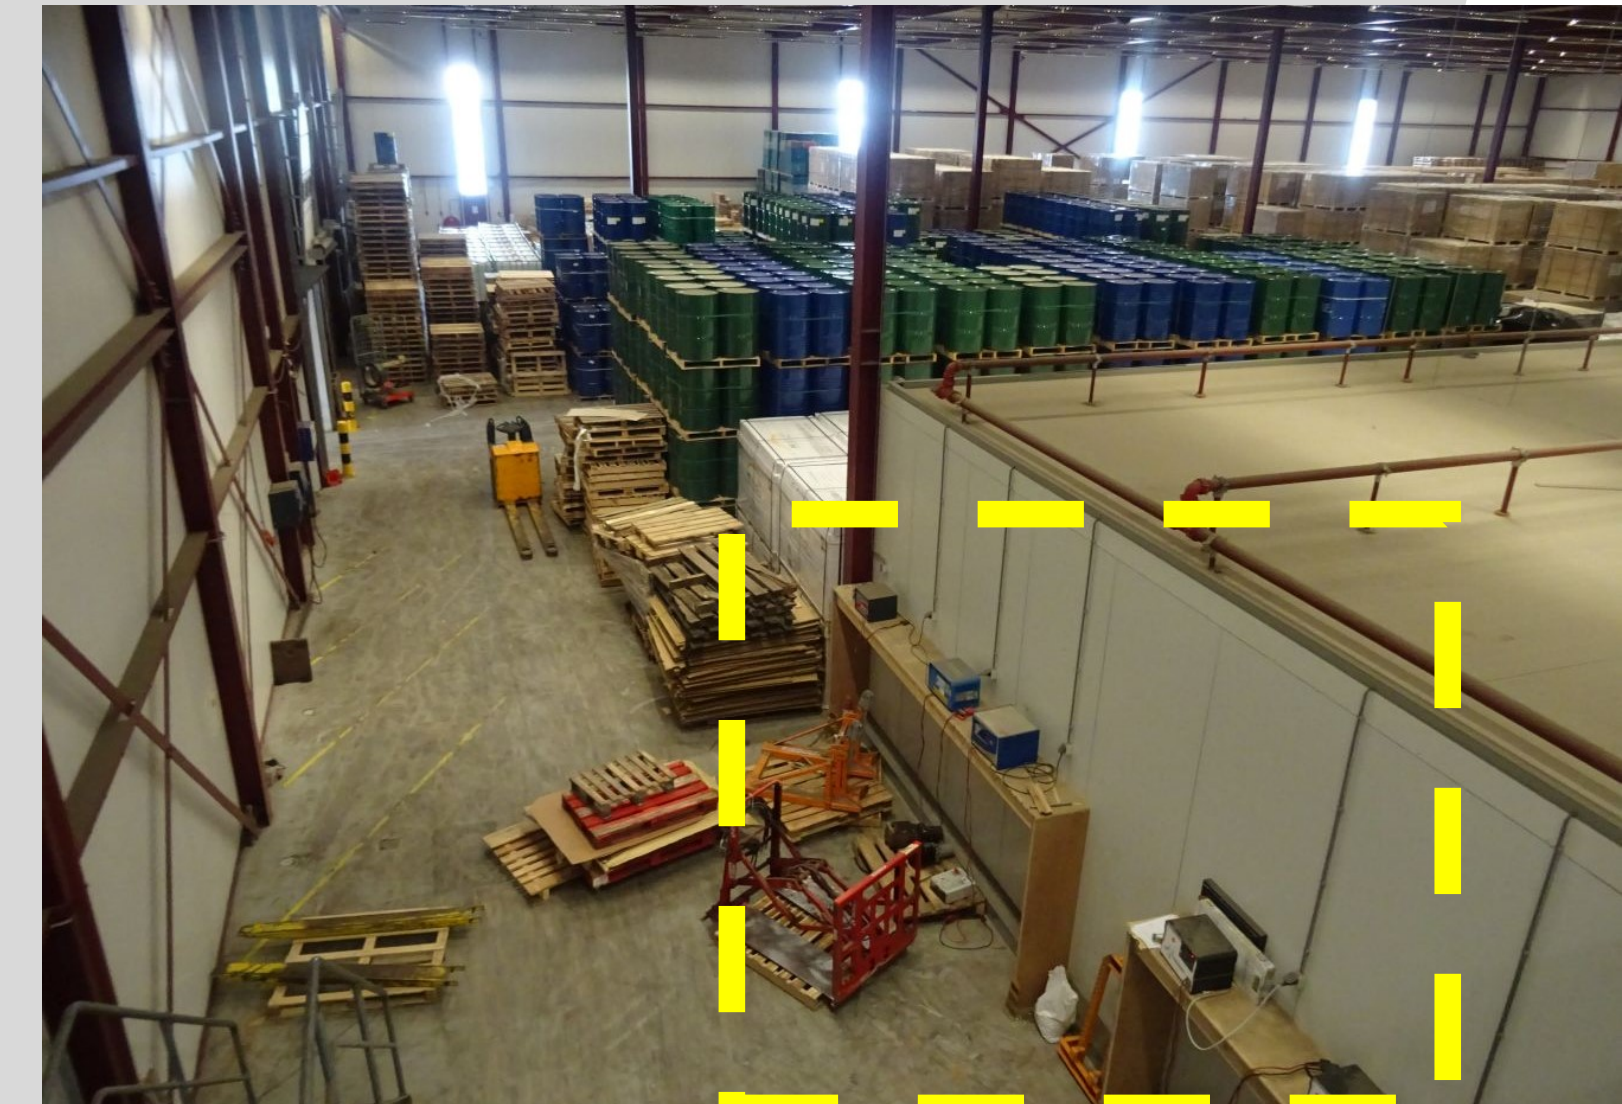
Photo 3: Ignition sources next to avoidable fire loads

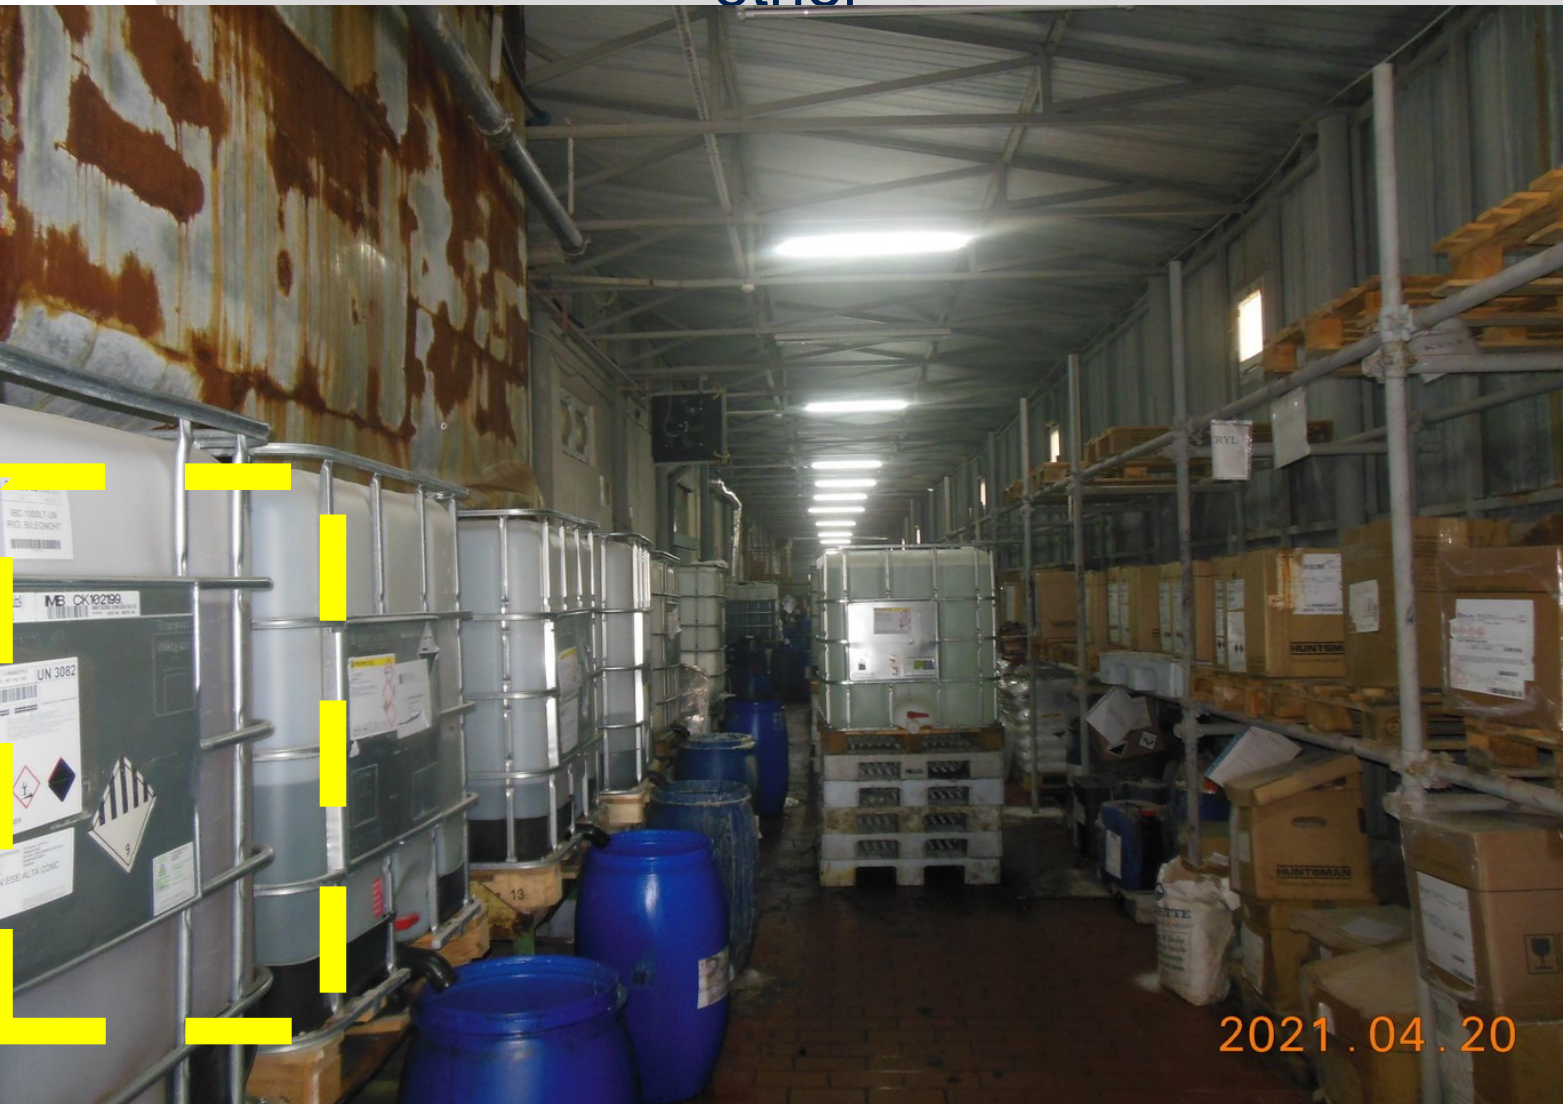
Photo 1: Different fire loads (cardboard, hazardous goods) directly next to each other

- **Distance between ignition sources (heat / electric current) and fire loads (as far as avoidable)**
 - 1.00 m = acceptable, 2.00 m = better
 - Marked "keep-out" area
- **Separation of large fire loads into several areas (fire breaks)**
 - Delays spreading
 - Eases extinguishing work

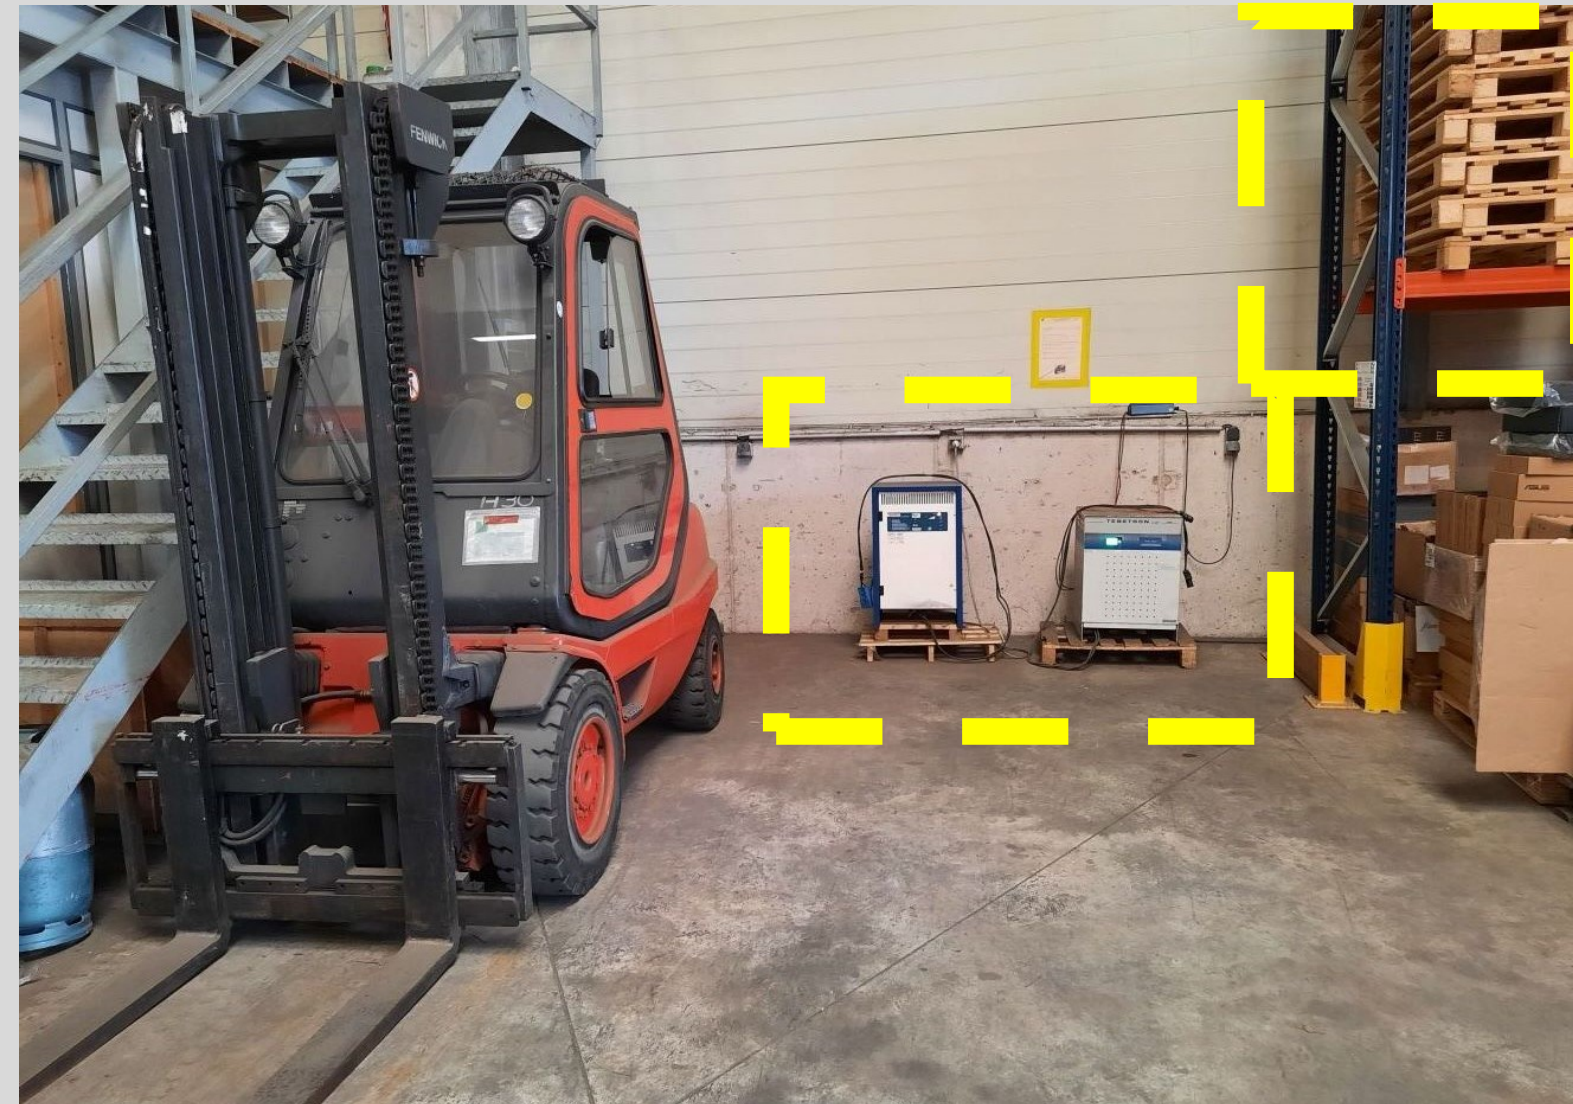
Photo 2: Wooden pallets under charging stations and empty pallets (avoidable)

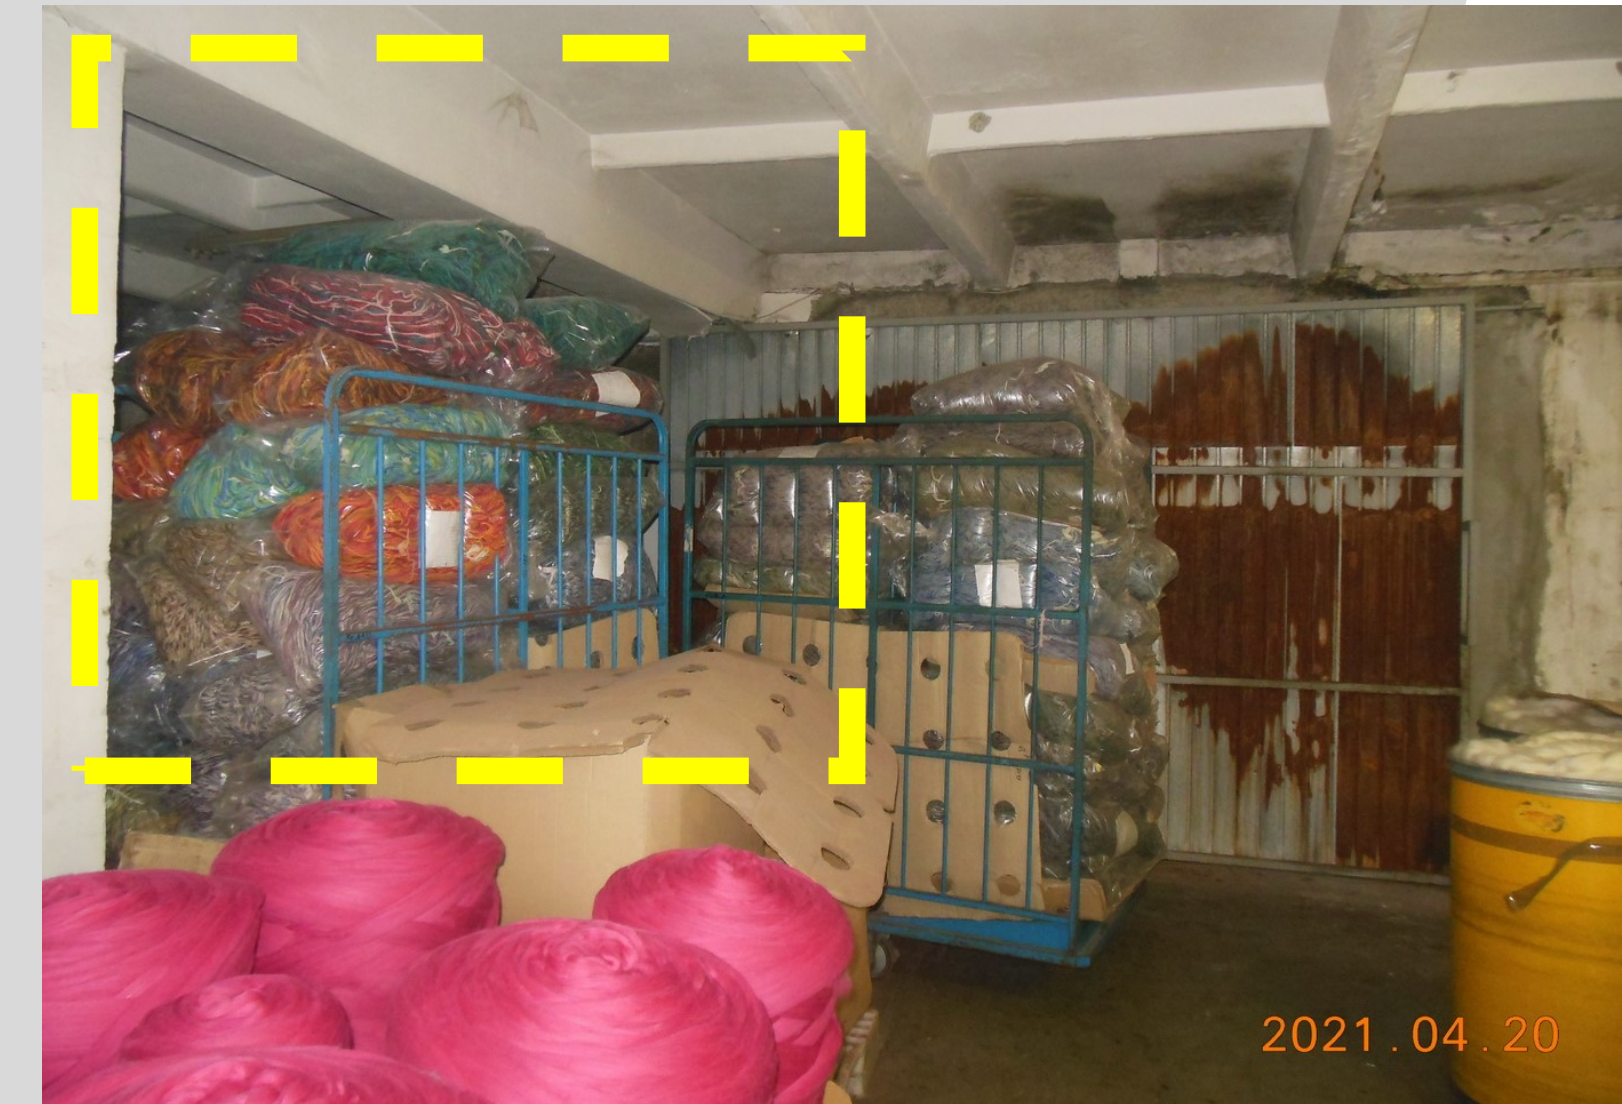
Photo 3: Fire loads up to the roof (heat accumulation)

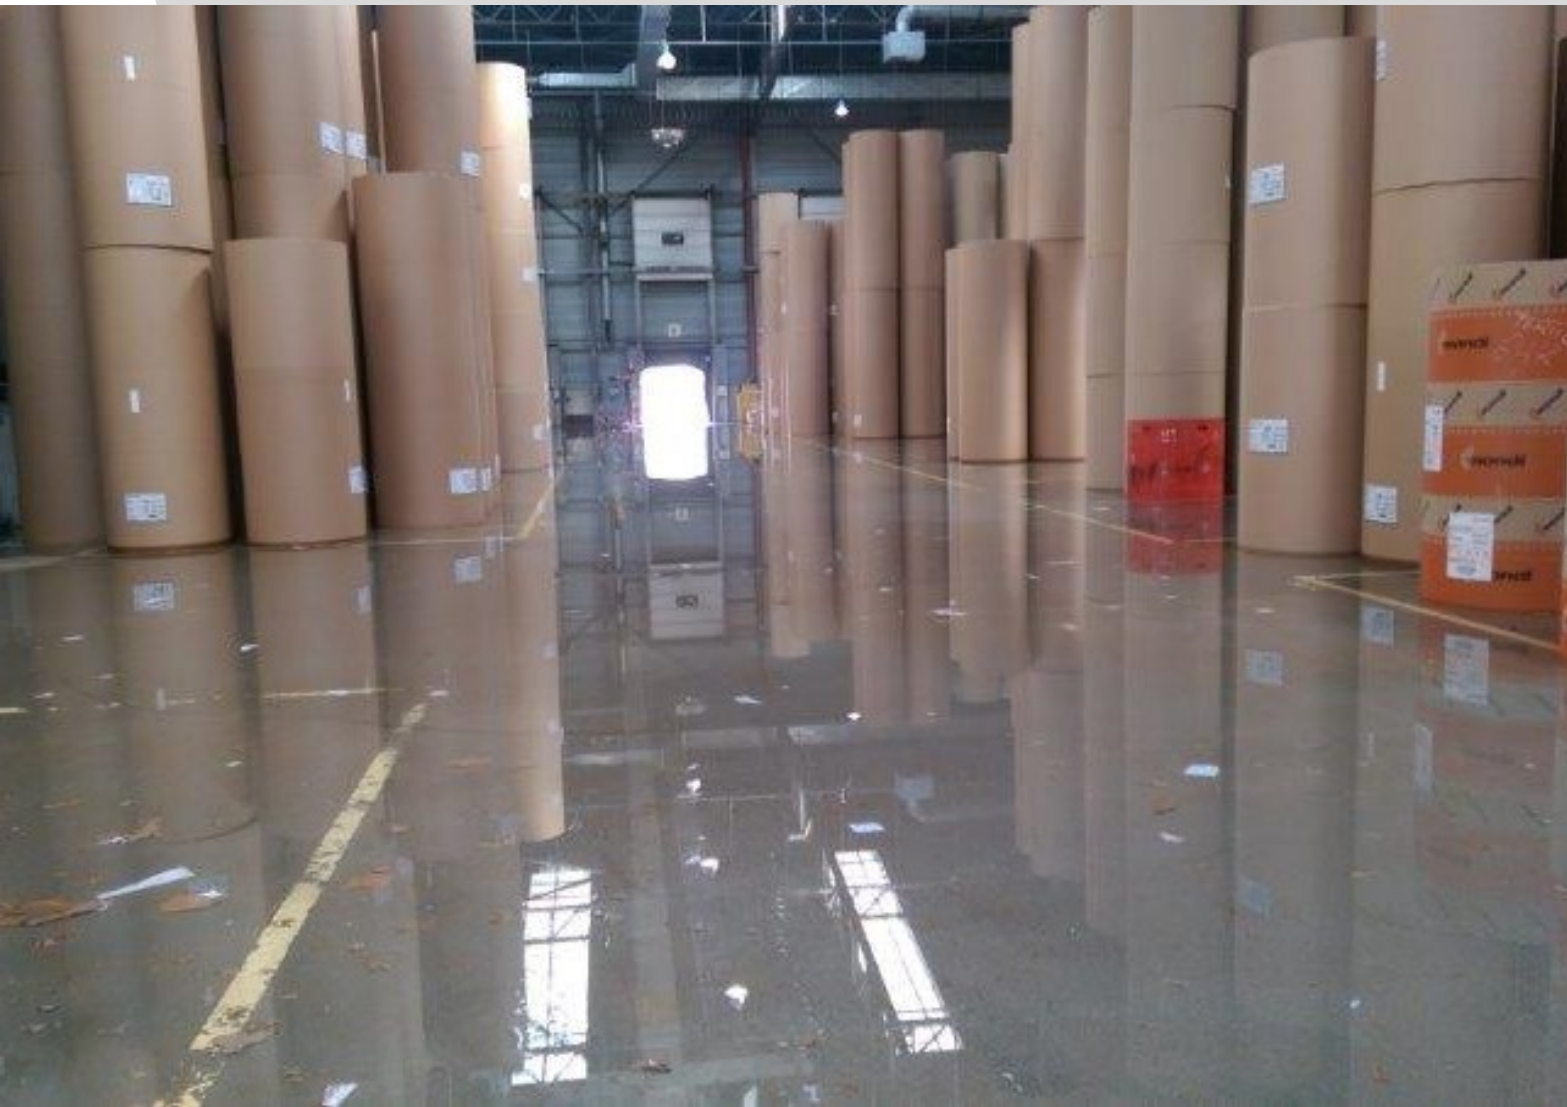
Photo 1: Rainwater in a warehouse with paper reels

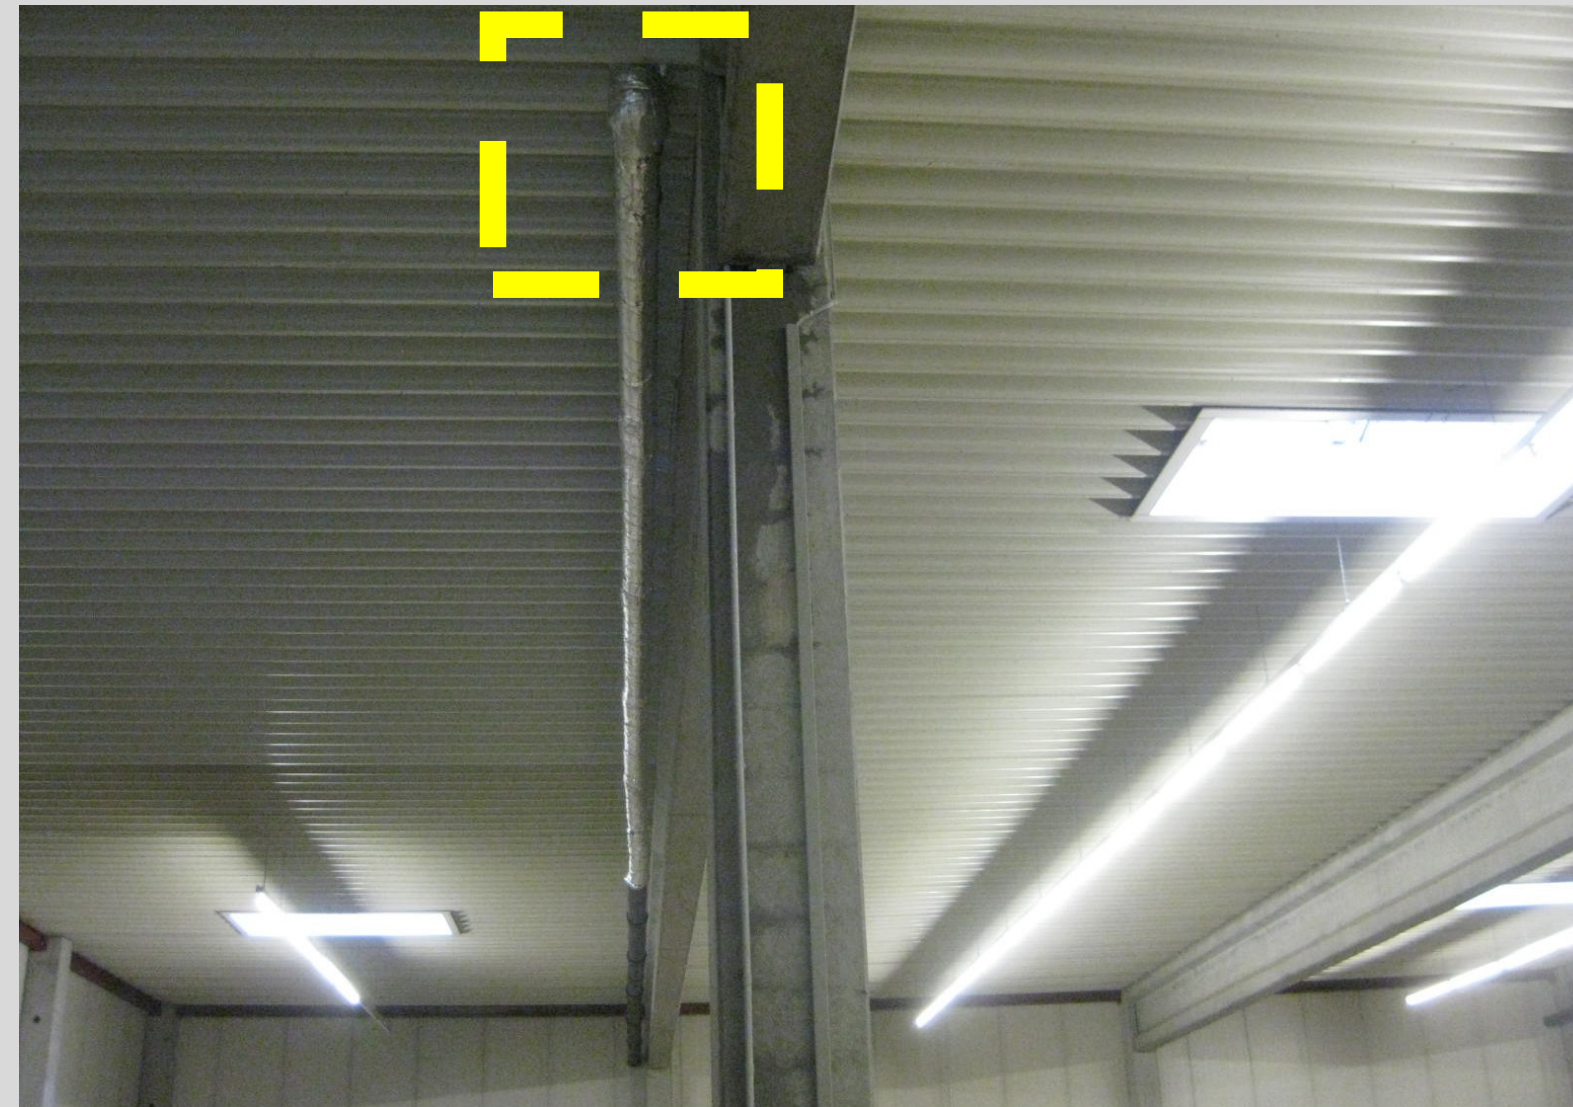
Photo 2: Already new horizontal pipe

- Downpipes made of PVC / plastic are often only plugged into each other
- Pipes designed for normal amounts rainwater, not for water standing in the pipe (weight)
 - May not be avoidable during heavy rain

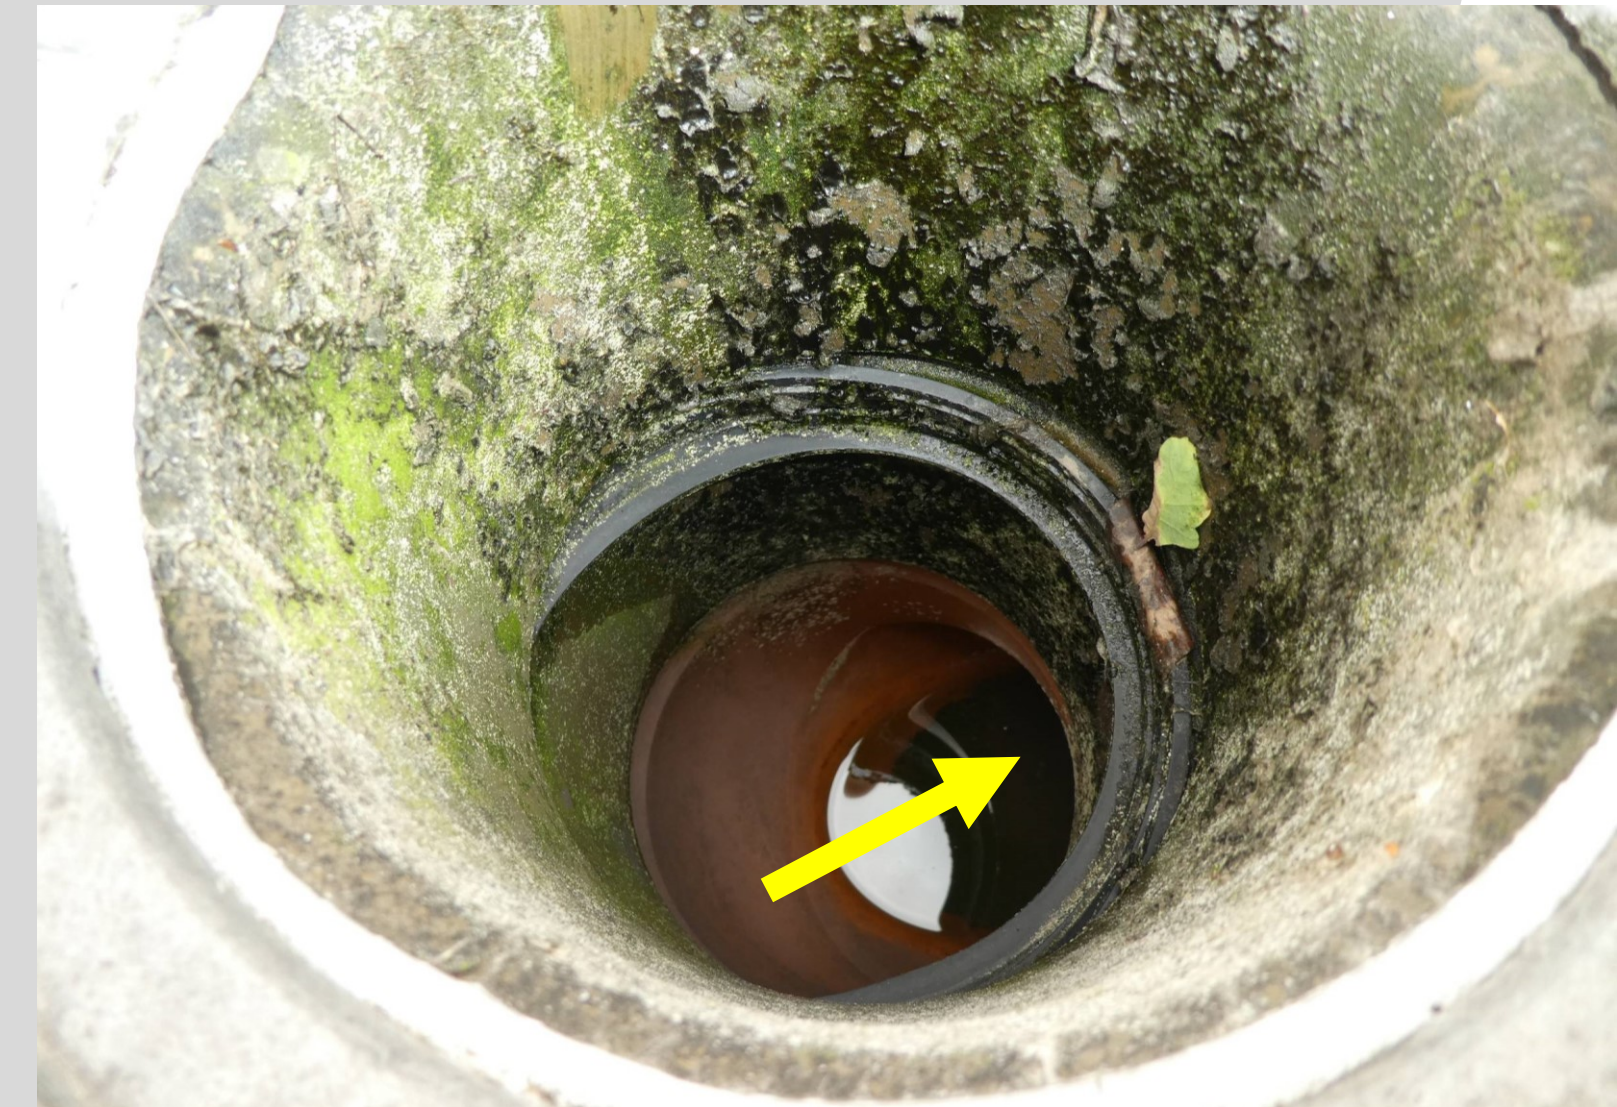
Photo 3: 90° bend in the roof drains

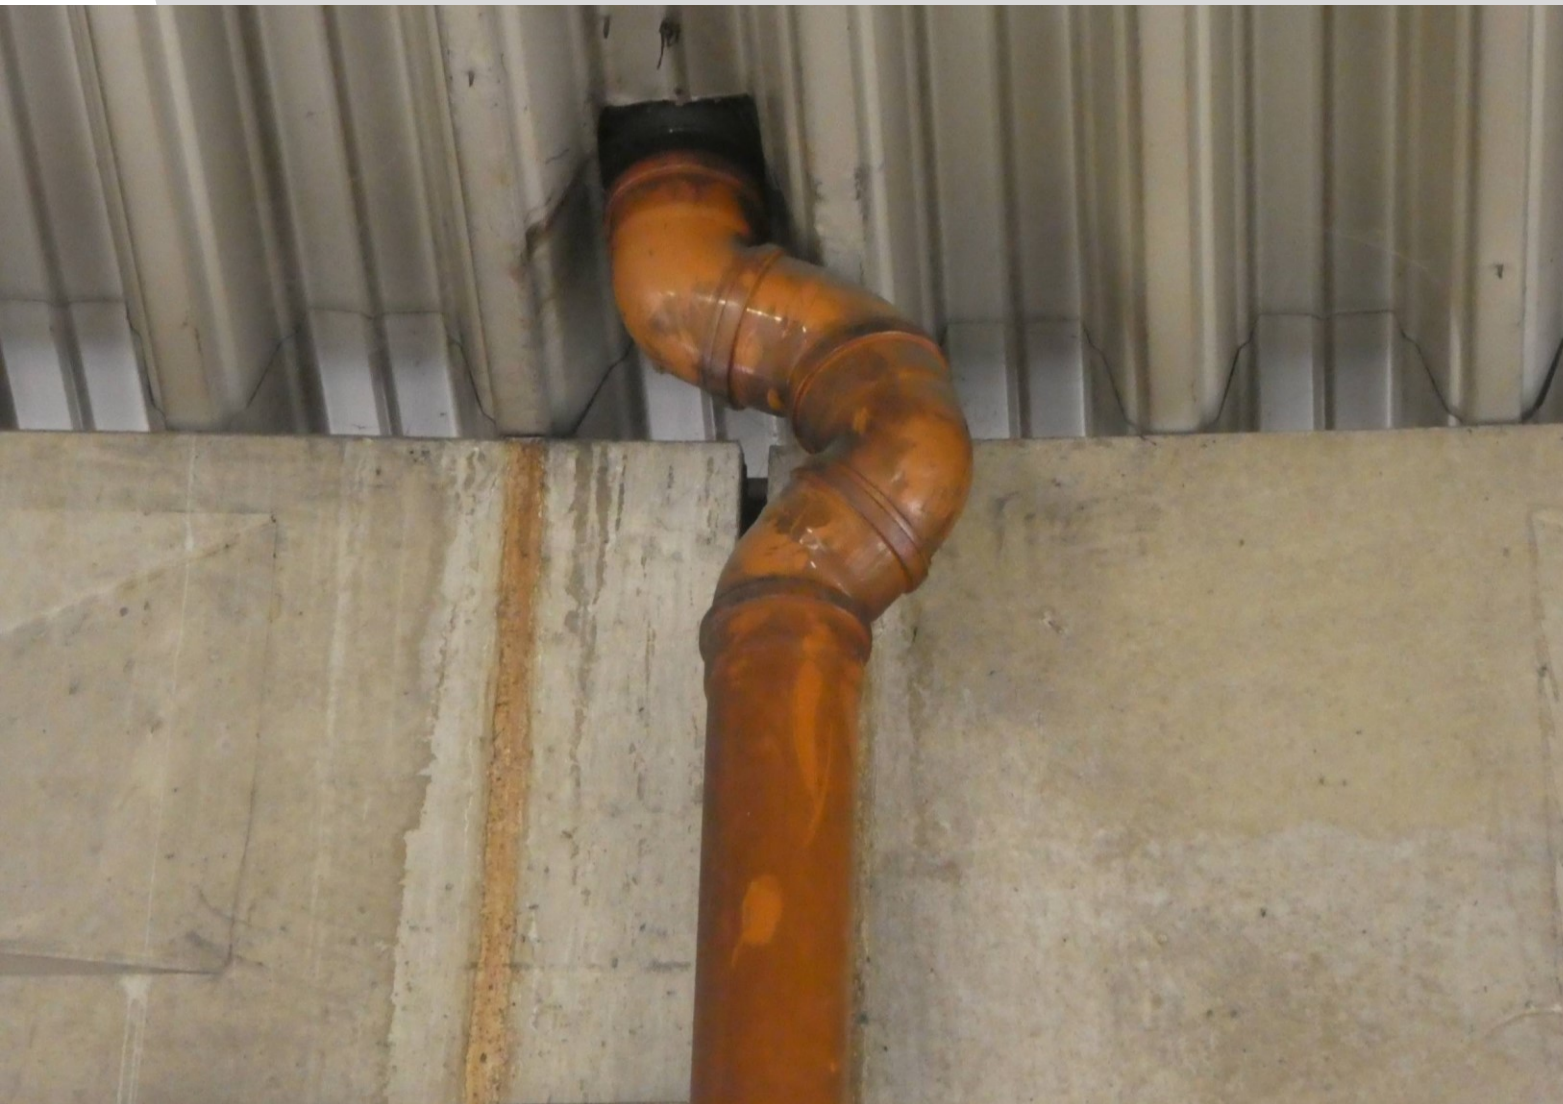
Photo 1: Parts plugged into each other

- Downpipes made of PVC / plastic are often only plugged into each other
- Pipes designed for normal amounts rainwater, not for water standing in the pipe (weight)
 - May not be avoidable during heavy rain
- Corrosion hardly detectable during visual inspection
 - If possible, no sensitive goods or high-value goods close to internal downpipes

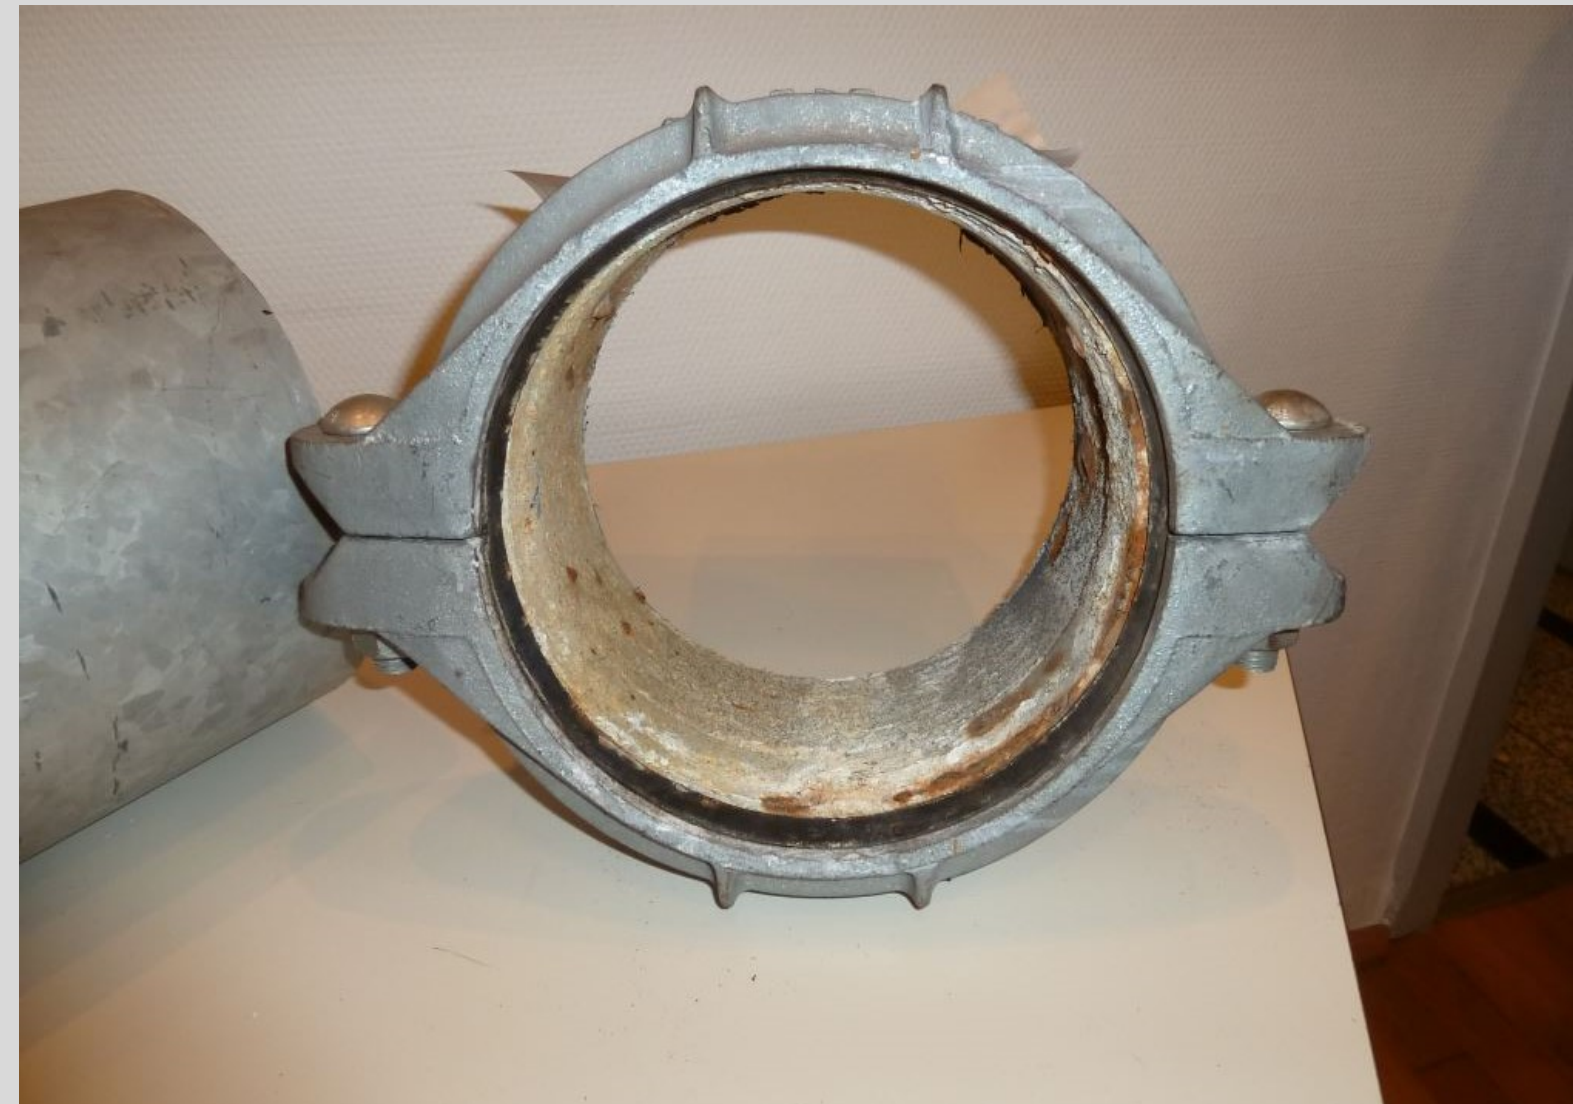
Photo 2: Corrosion on a metal joint socket
