Static risks from the perspective of a cargo and warehouse surveyor

- less obvious risks -

Battermann & Tillery Global Marine GmbH

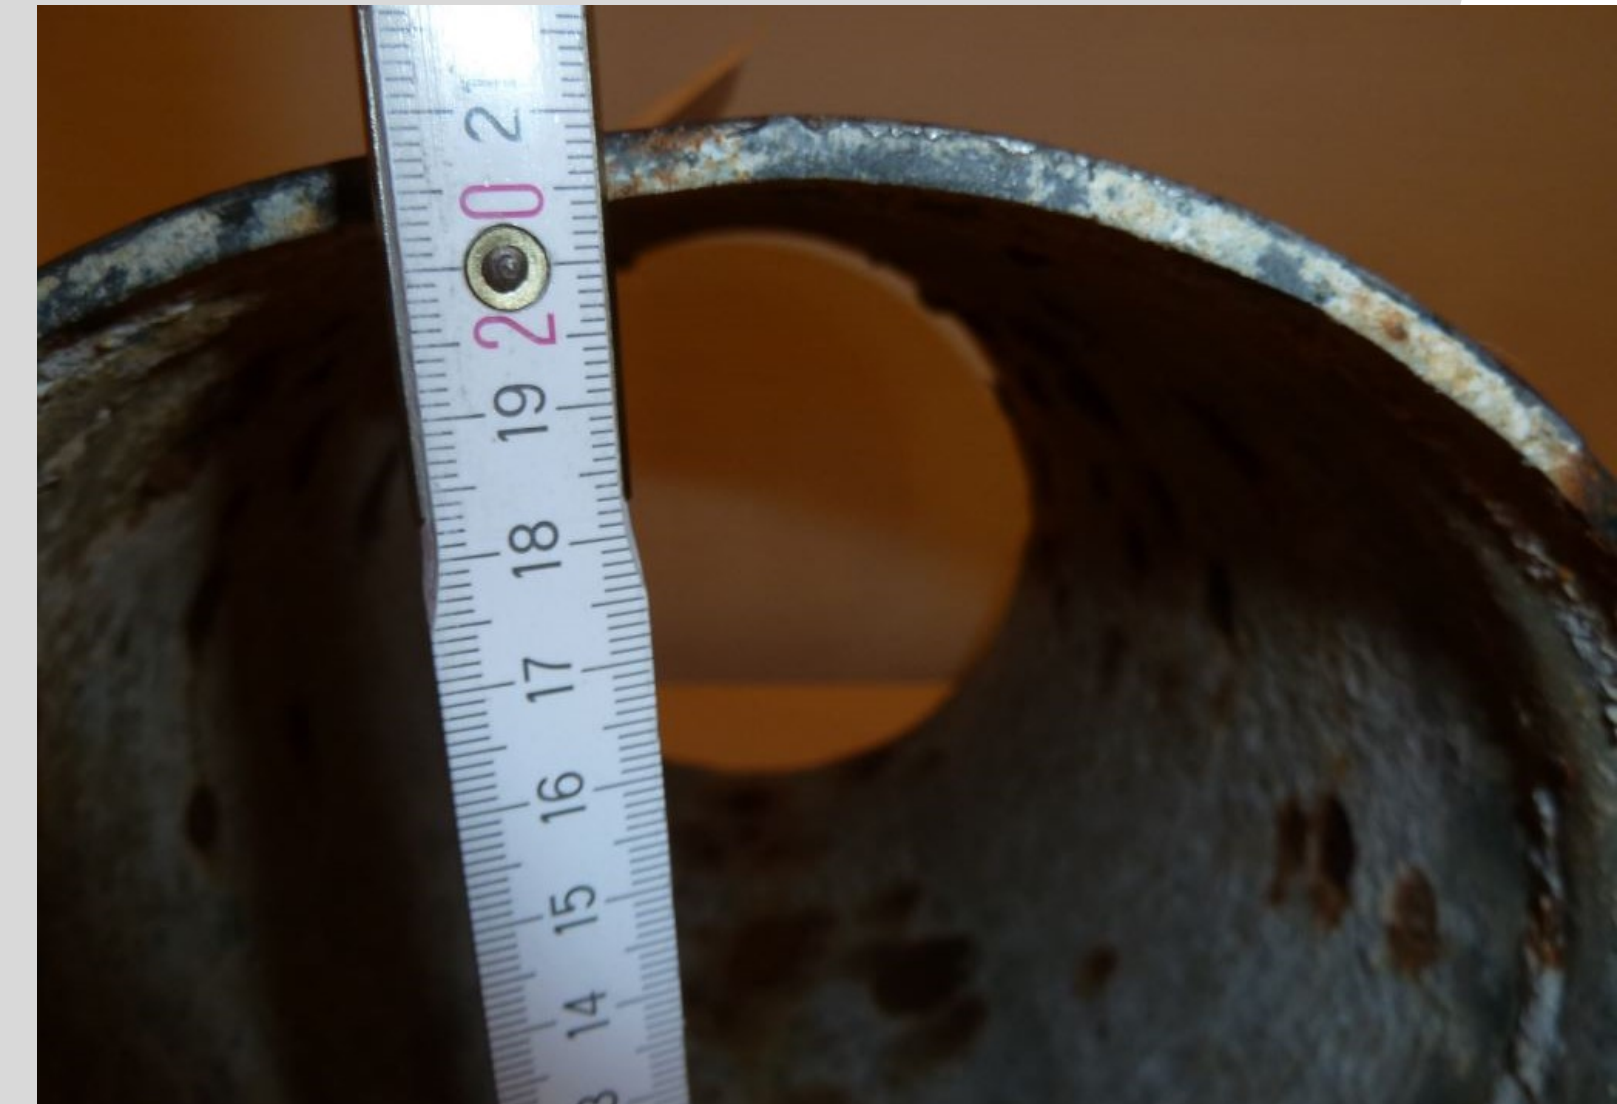
Photo 3: Corrosion on a metal pipe

- Downpipes made of PVC / plastic are often only plugged into each other
- Pipes designed for normal amounts rainwater, not for water standing in the pipe (weight)
 - May not be avoidable during heavy rain
- Corrosion hardly detectable during visual inspection
 - If possible, no sensitive goods or high-value goods close to internal downpipes

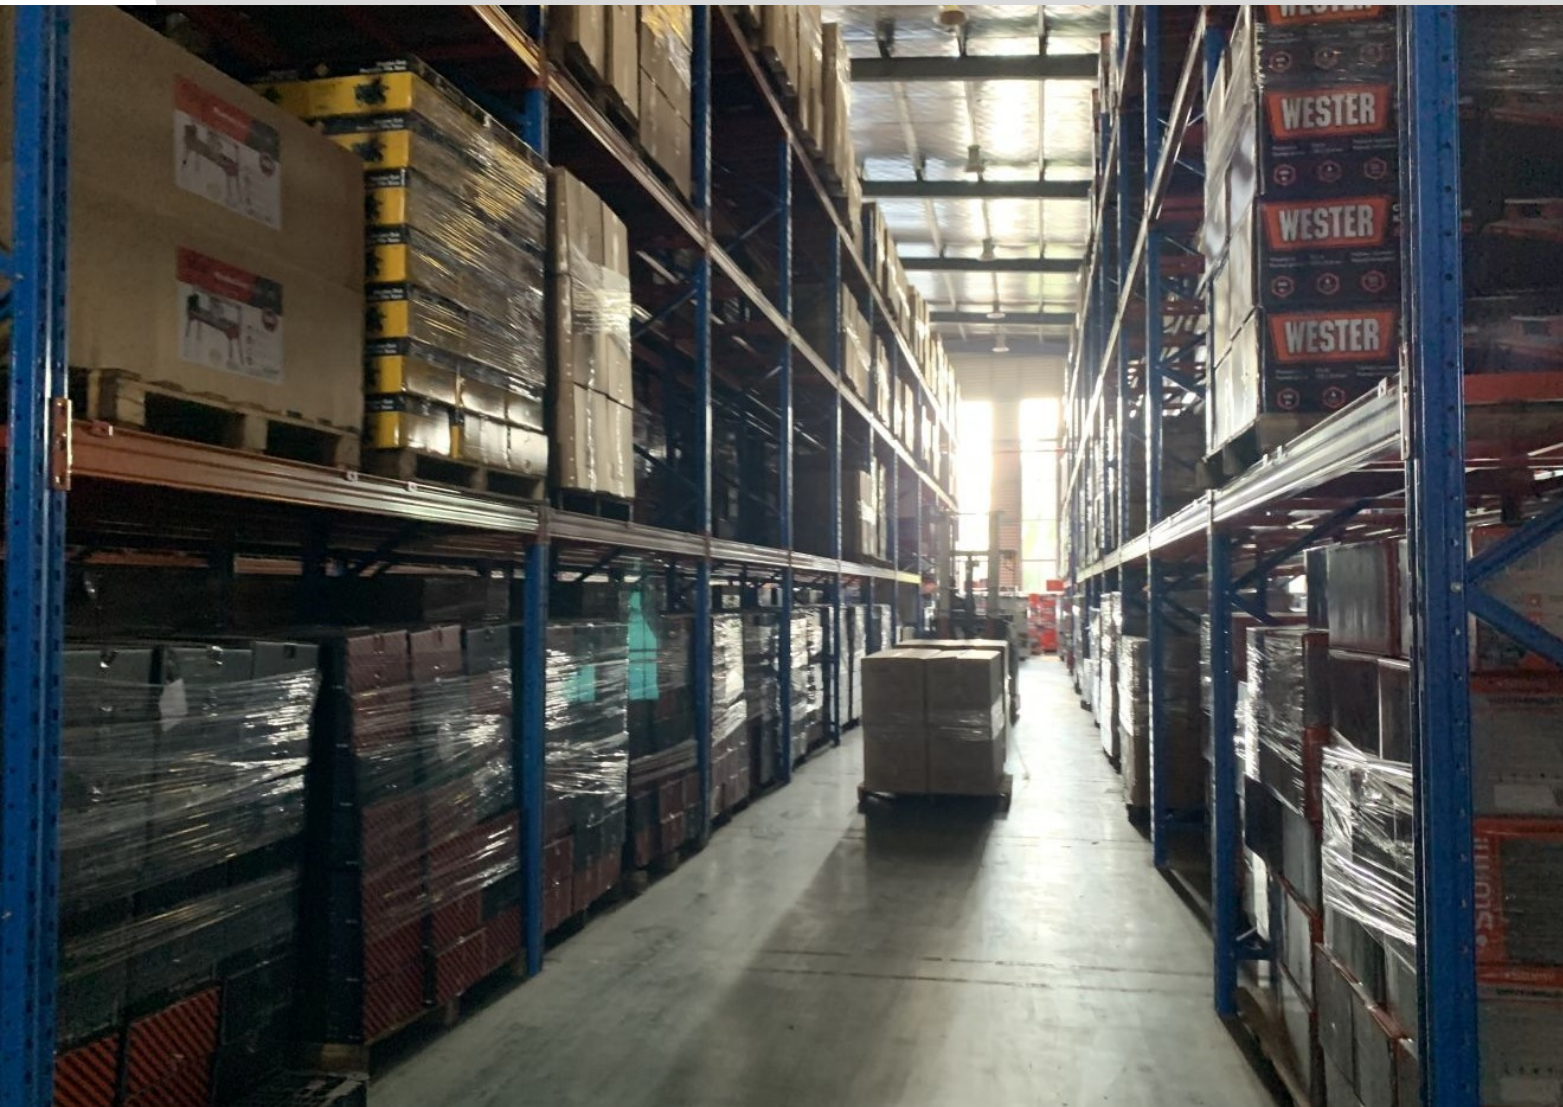
Photo 1: No collision protection

- **Shelves are designed for static loads from above**
 - A certified shelf can still collapse
 - Some resistance to light impacts, collision protection increase this resistance
- **Required strength of collision protection depends on the weight and speed of the forklift trucks**
 - Wide aisles reduce the risk of contact, but at the same time increase the potential travelling speed

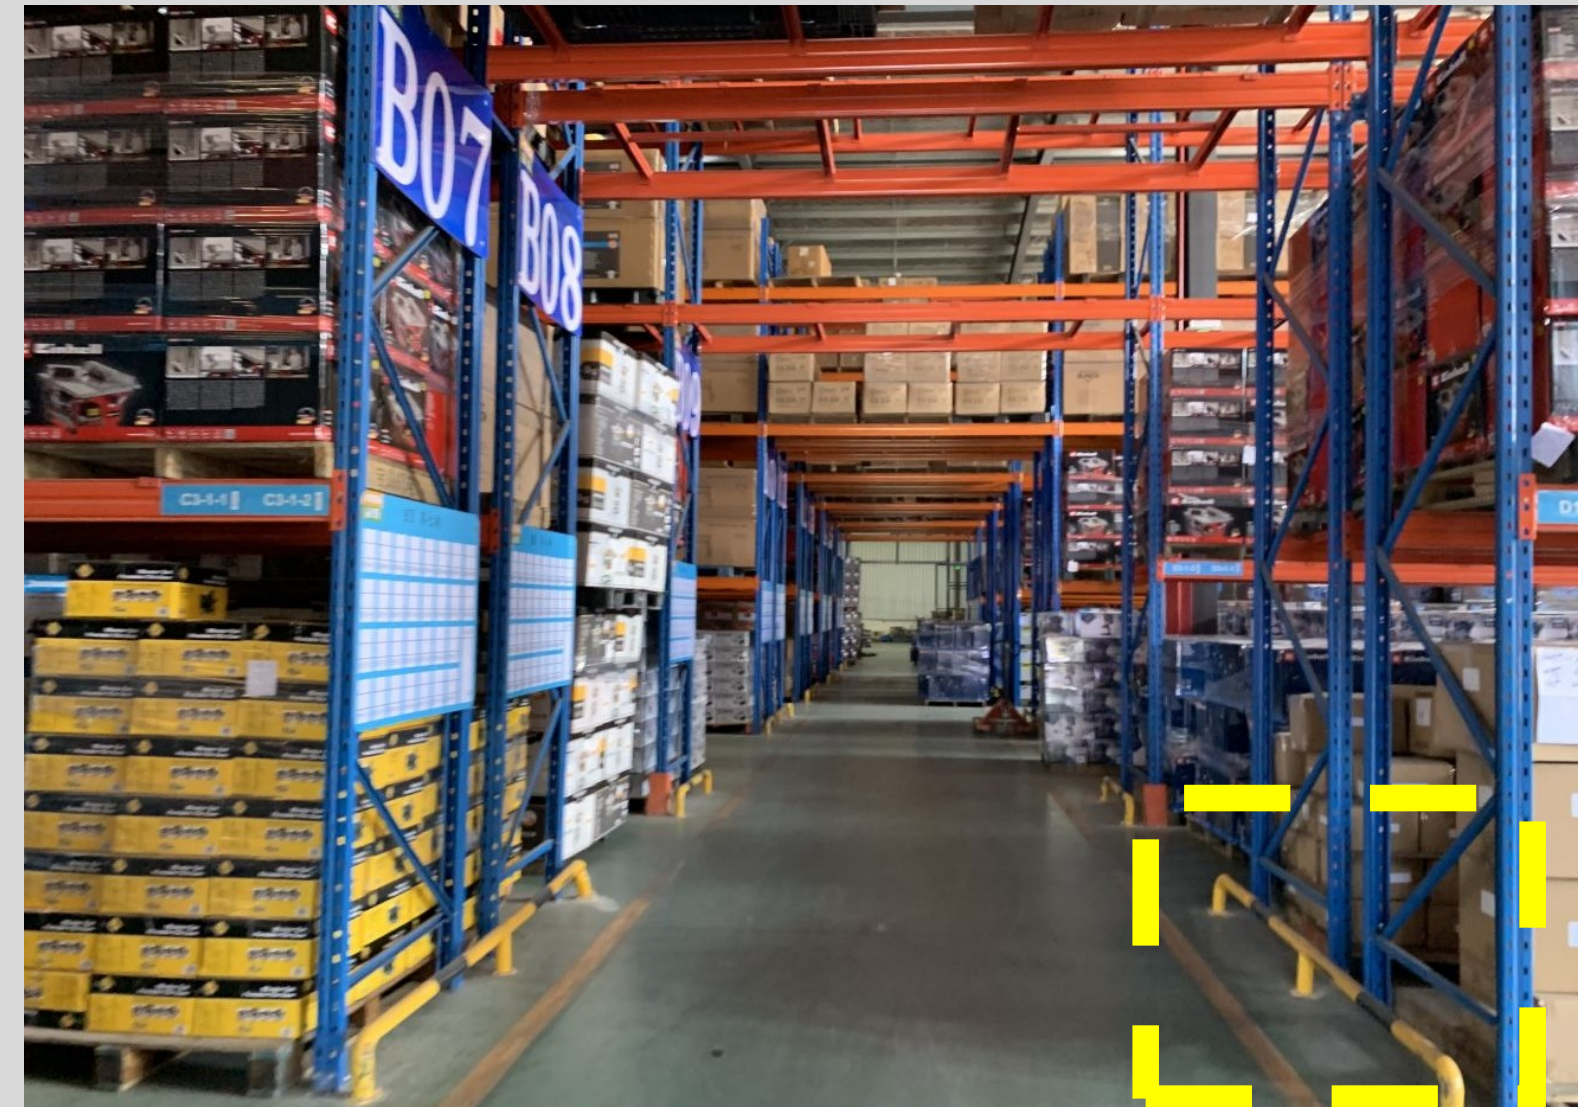
Photo 2: Collision protection partly installed

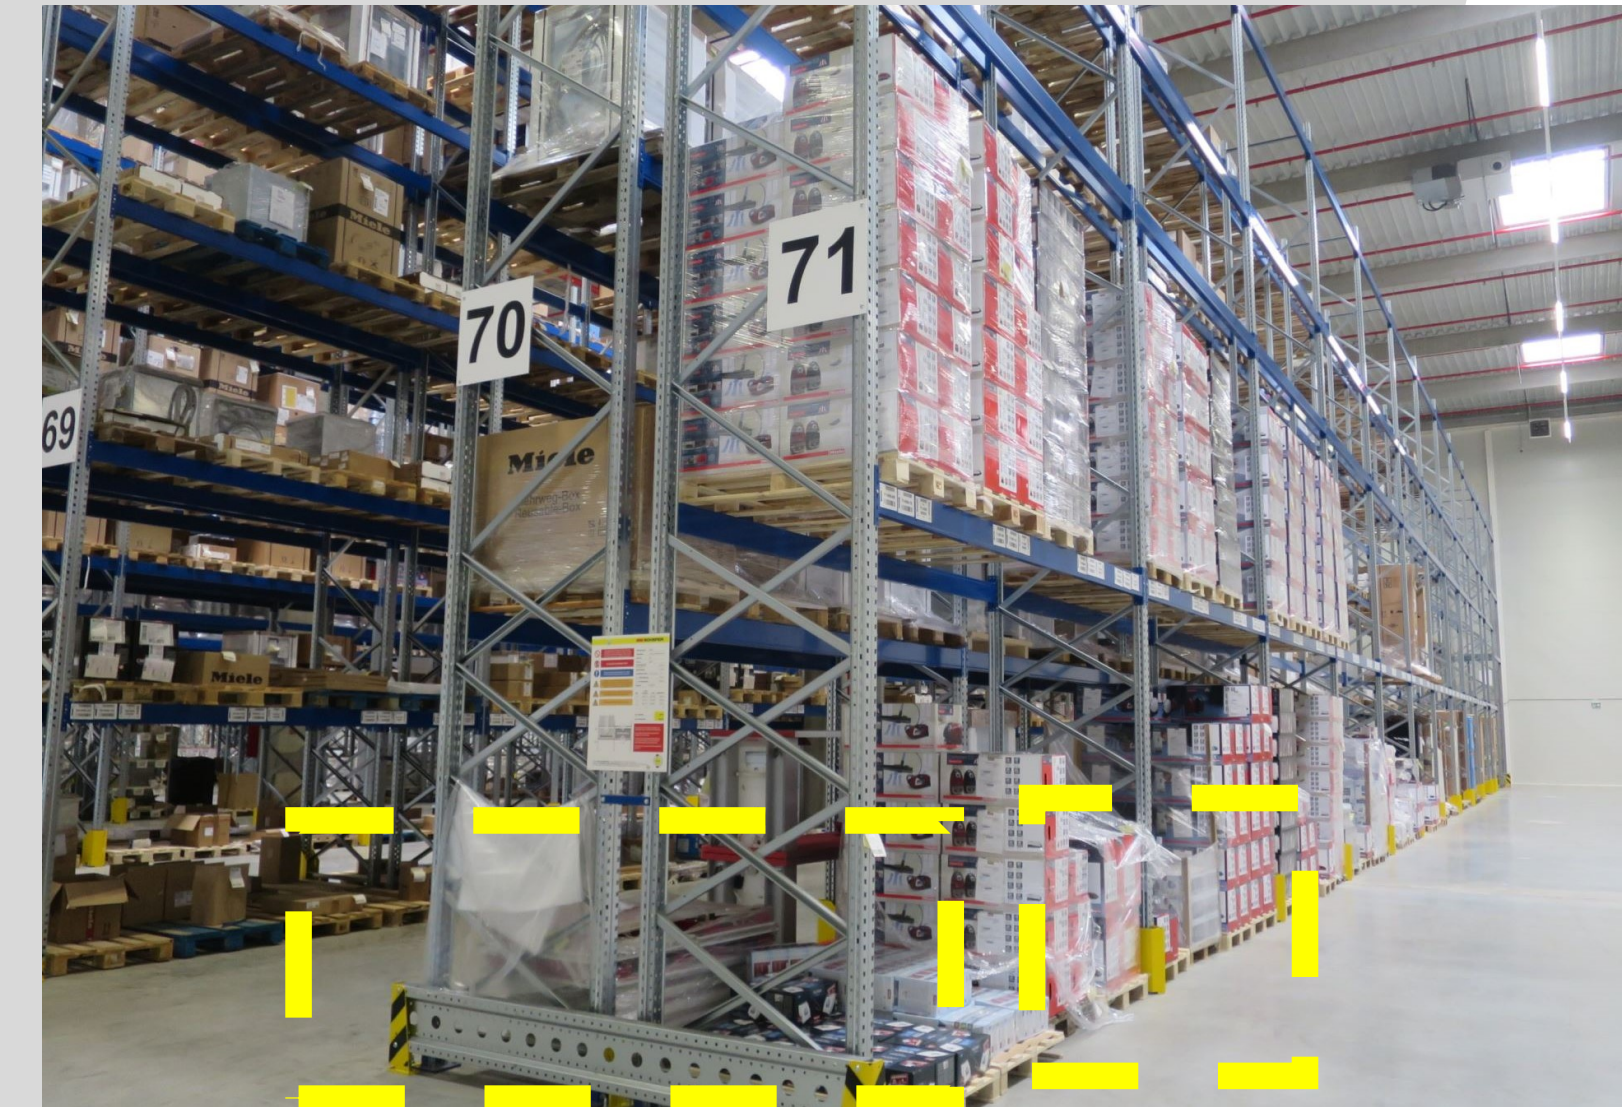
Photo 3: Every shelf support protected

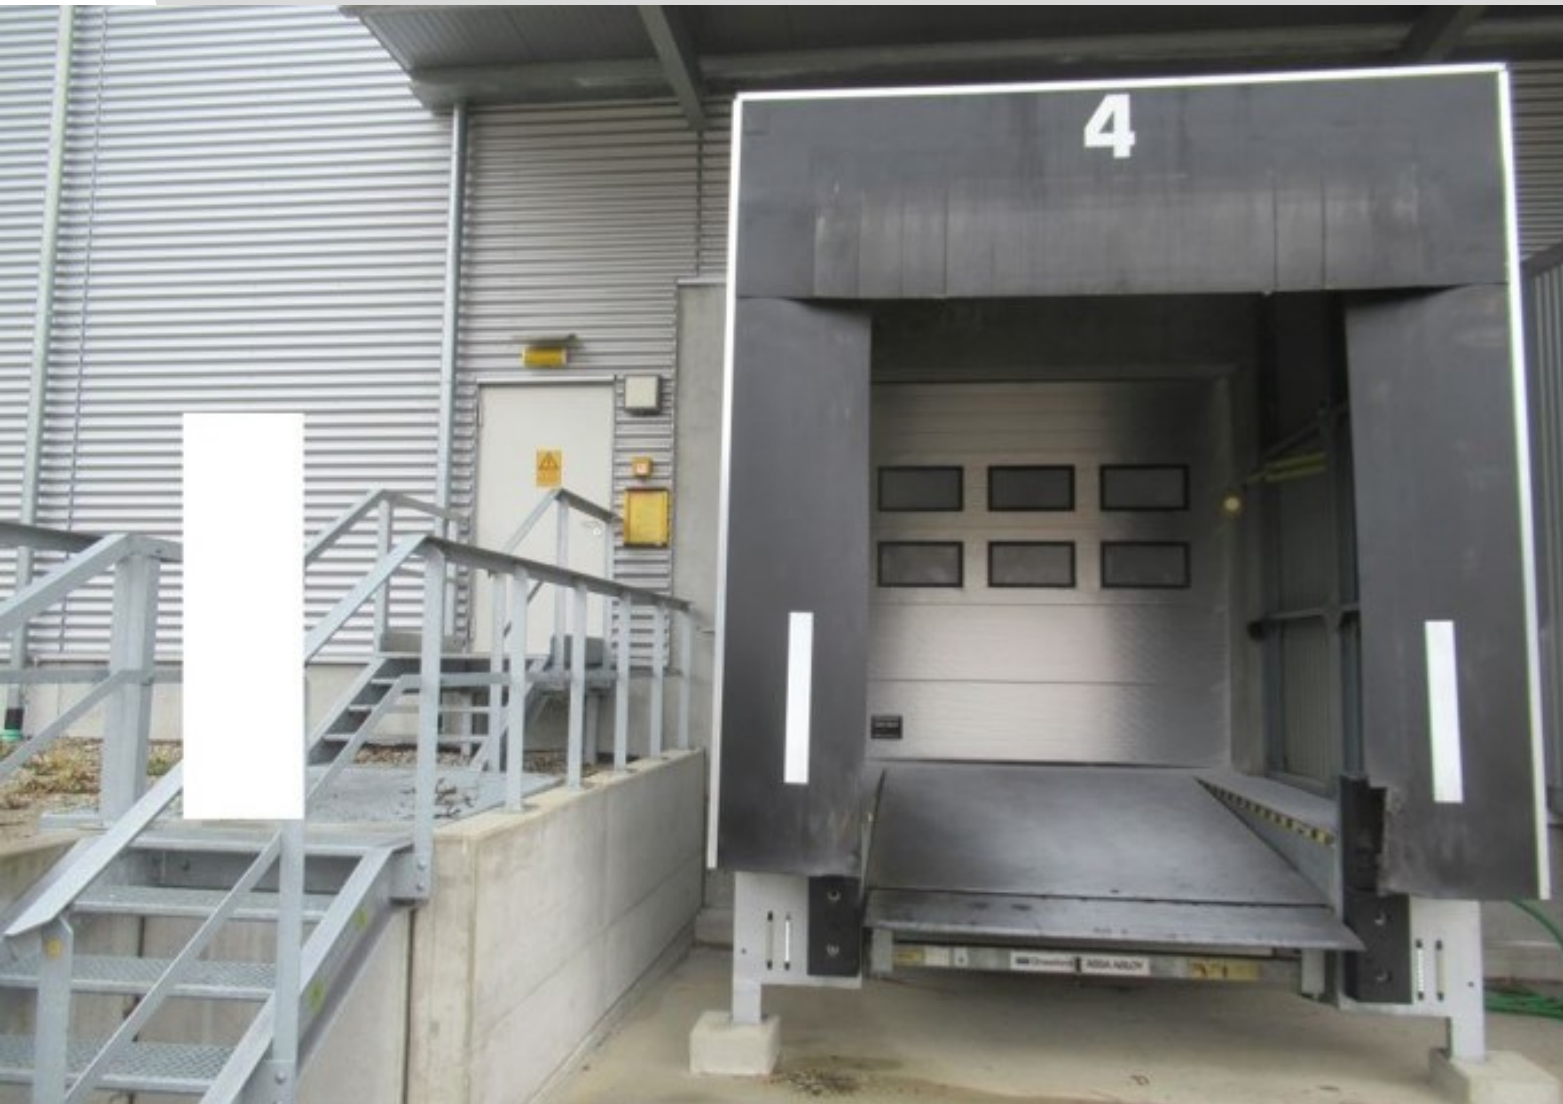
Photo 1: Entrance to the warehouse

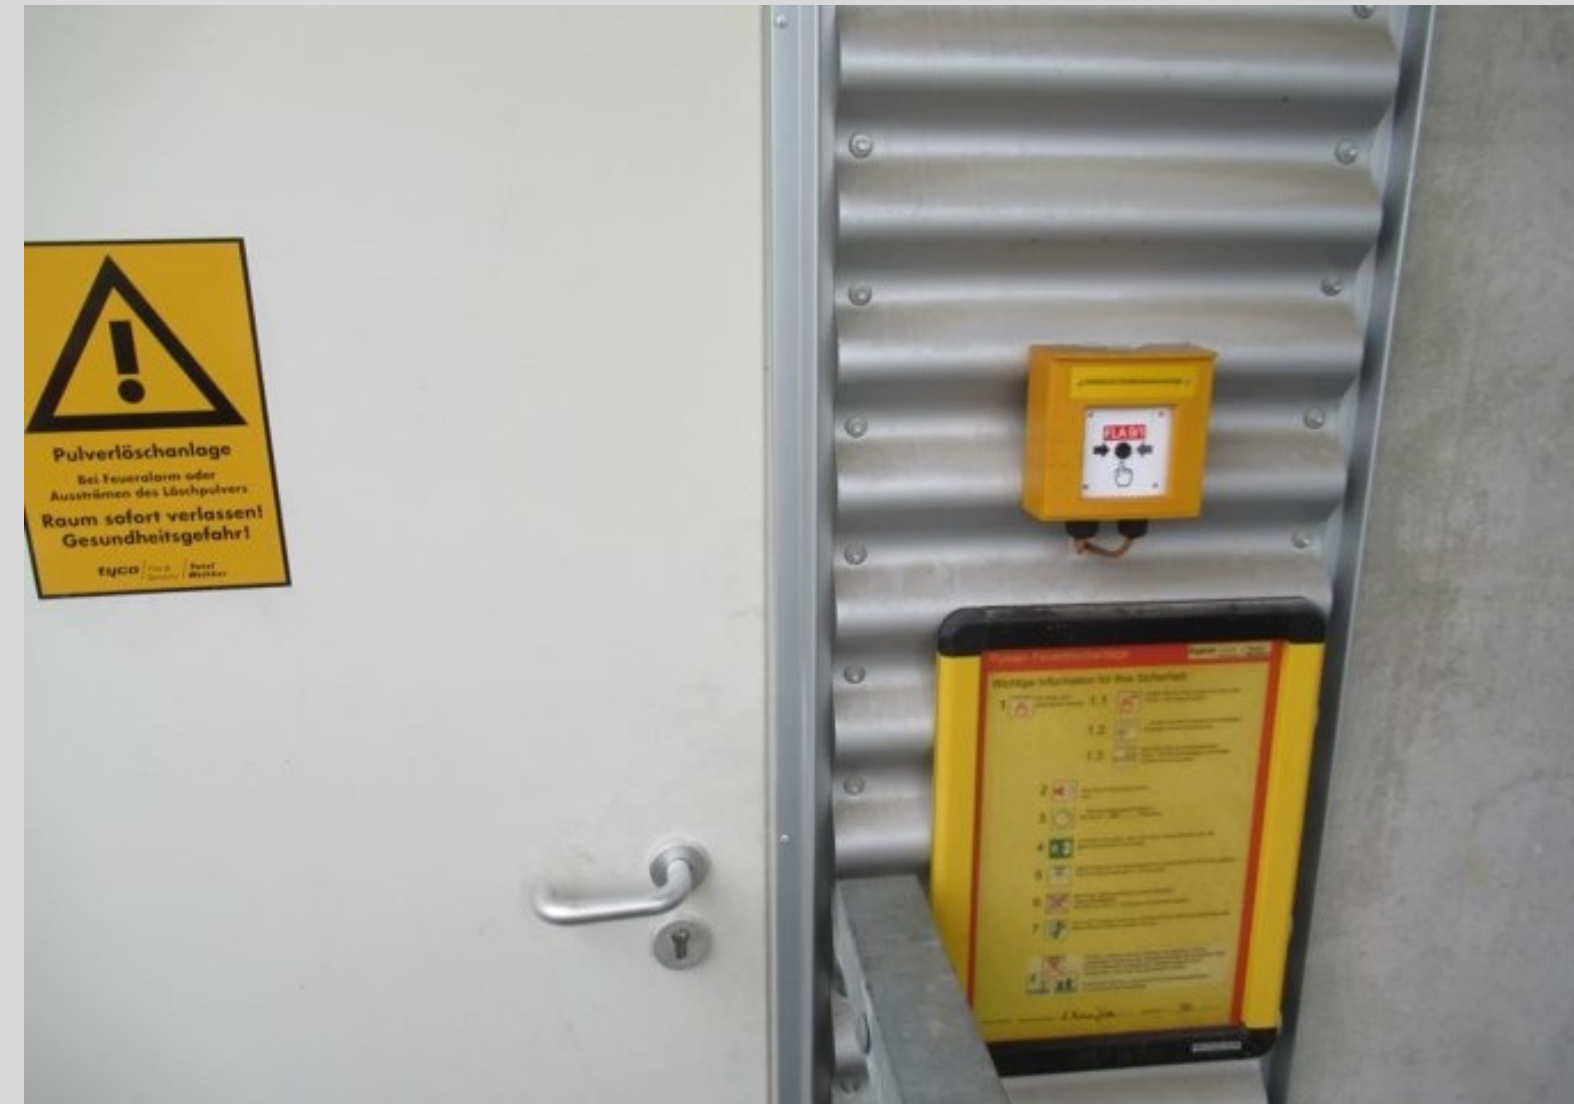
Photo 2: Switch next to mandoor

- Normally, a bell is placed at about this position
- Labelling is German (only)

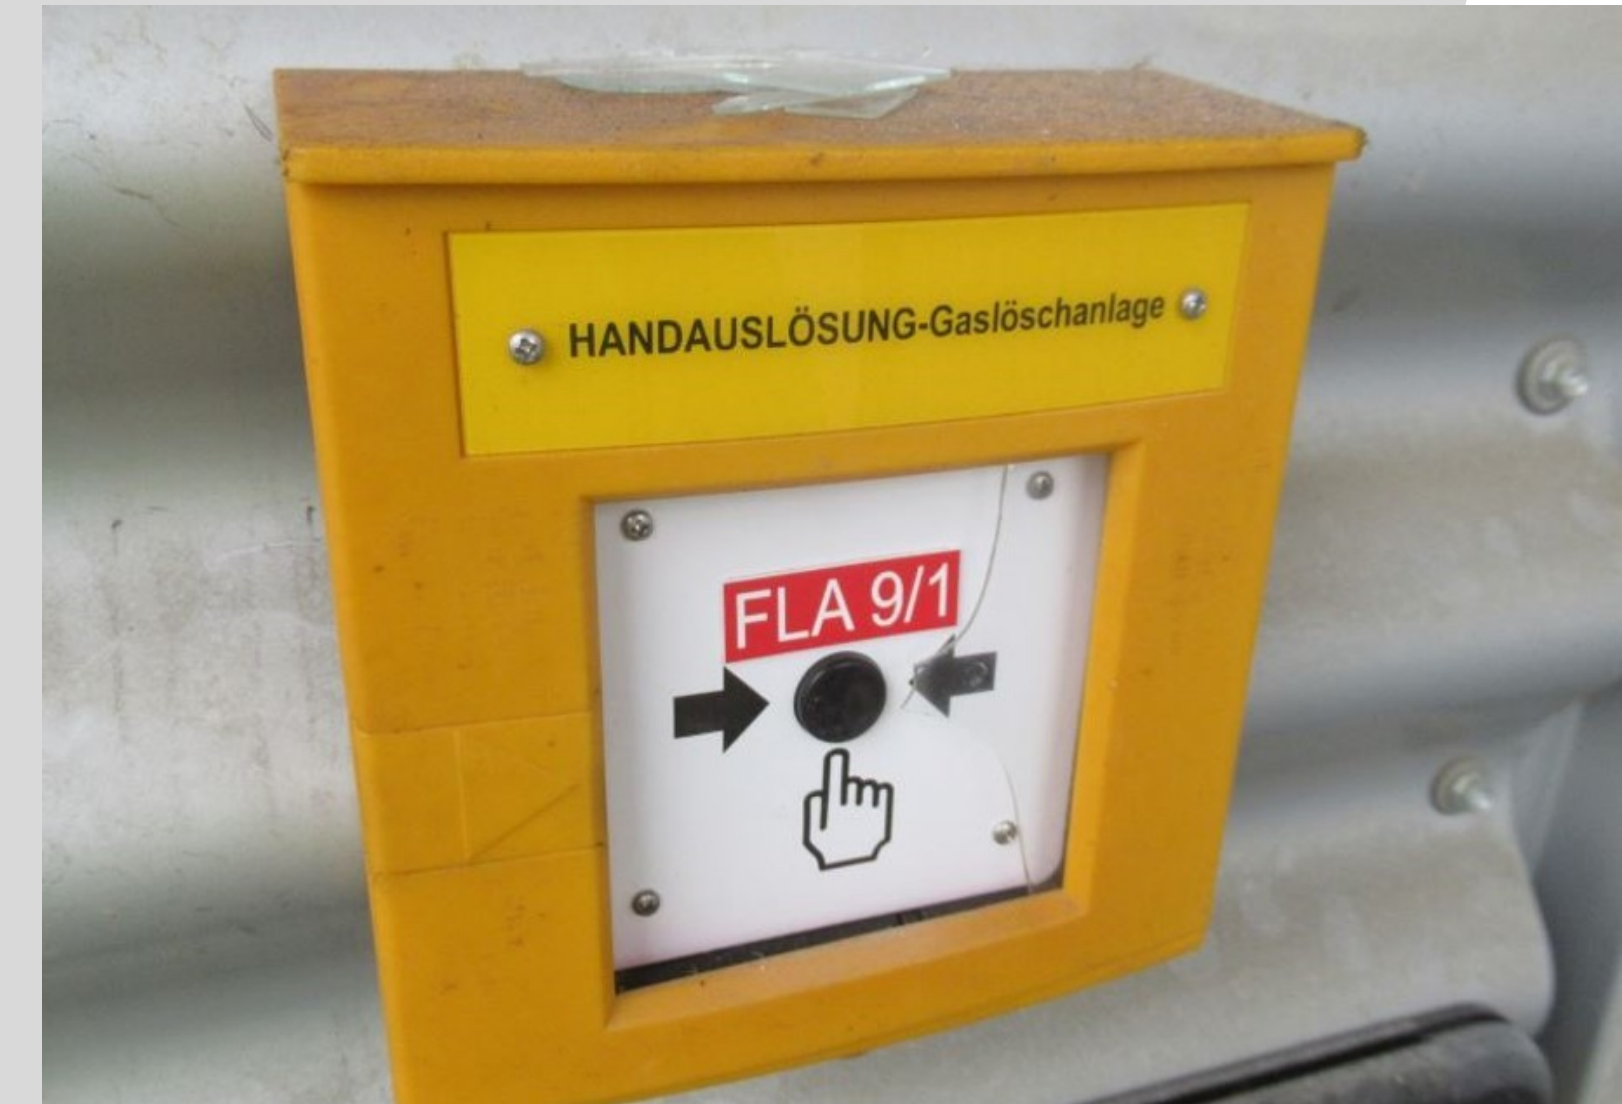
Photo 3: Gas extinguishing system

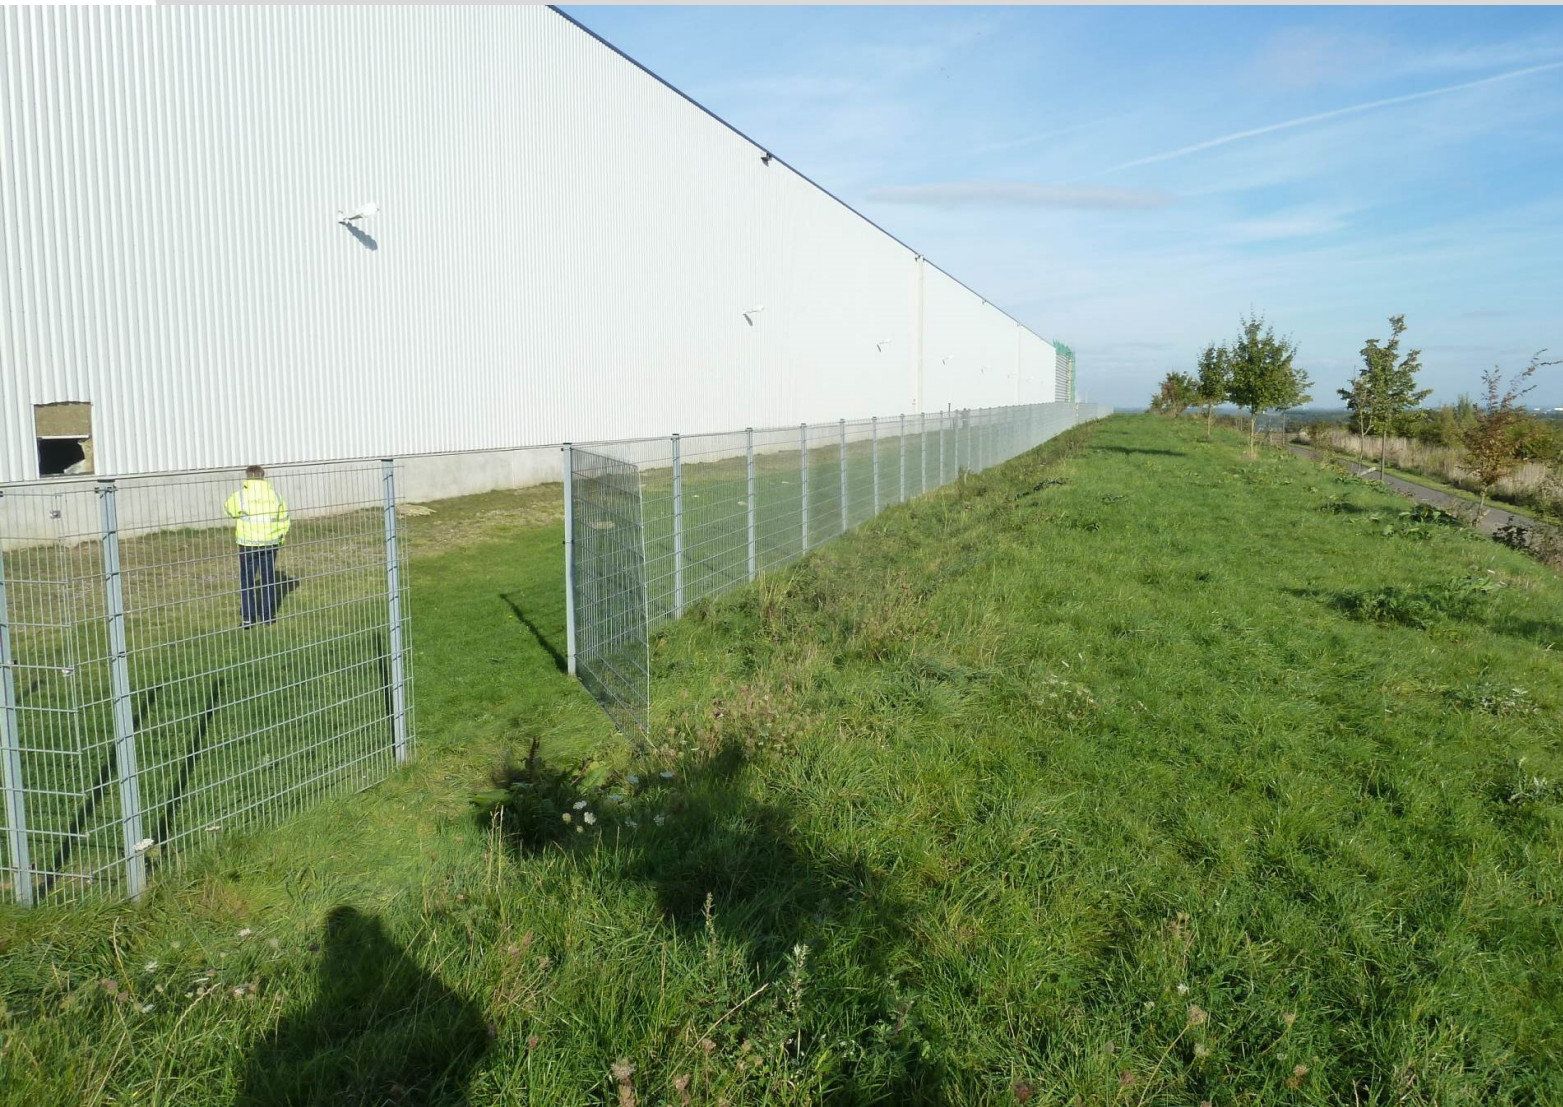
Photo 1: Fence and outer wall opened

- Burglary alarm system was in place - but only at the entrances and in the area of the loading gates
- Surveillance system was in place - but only at the entrances and in the area of the loading gates
- Security guard was on duty – but in an external office, approach to the warehouse 3 times per night or in case of alarm

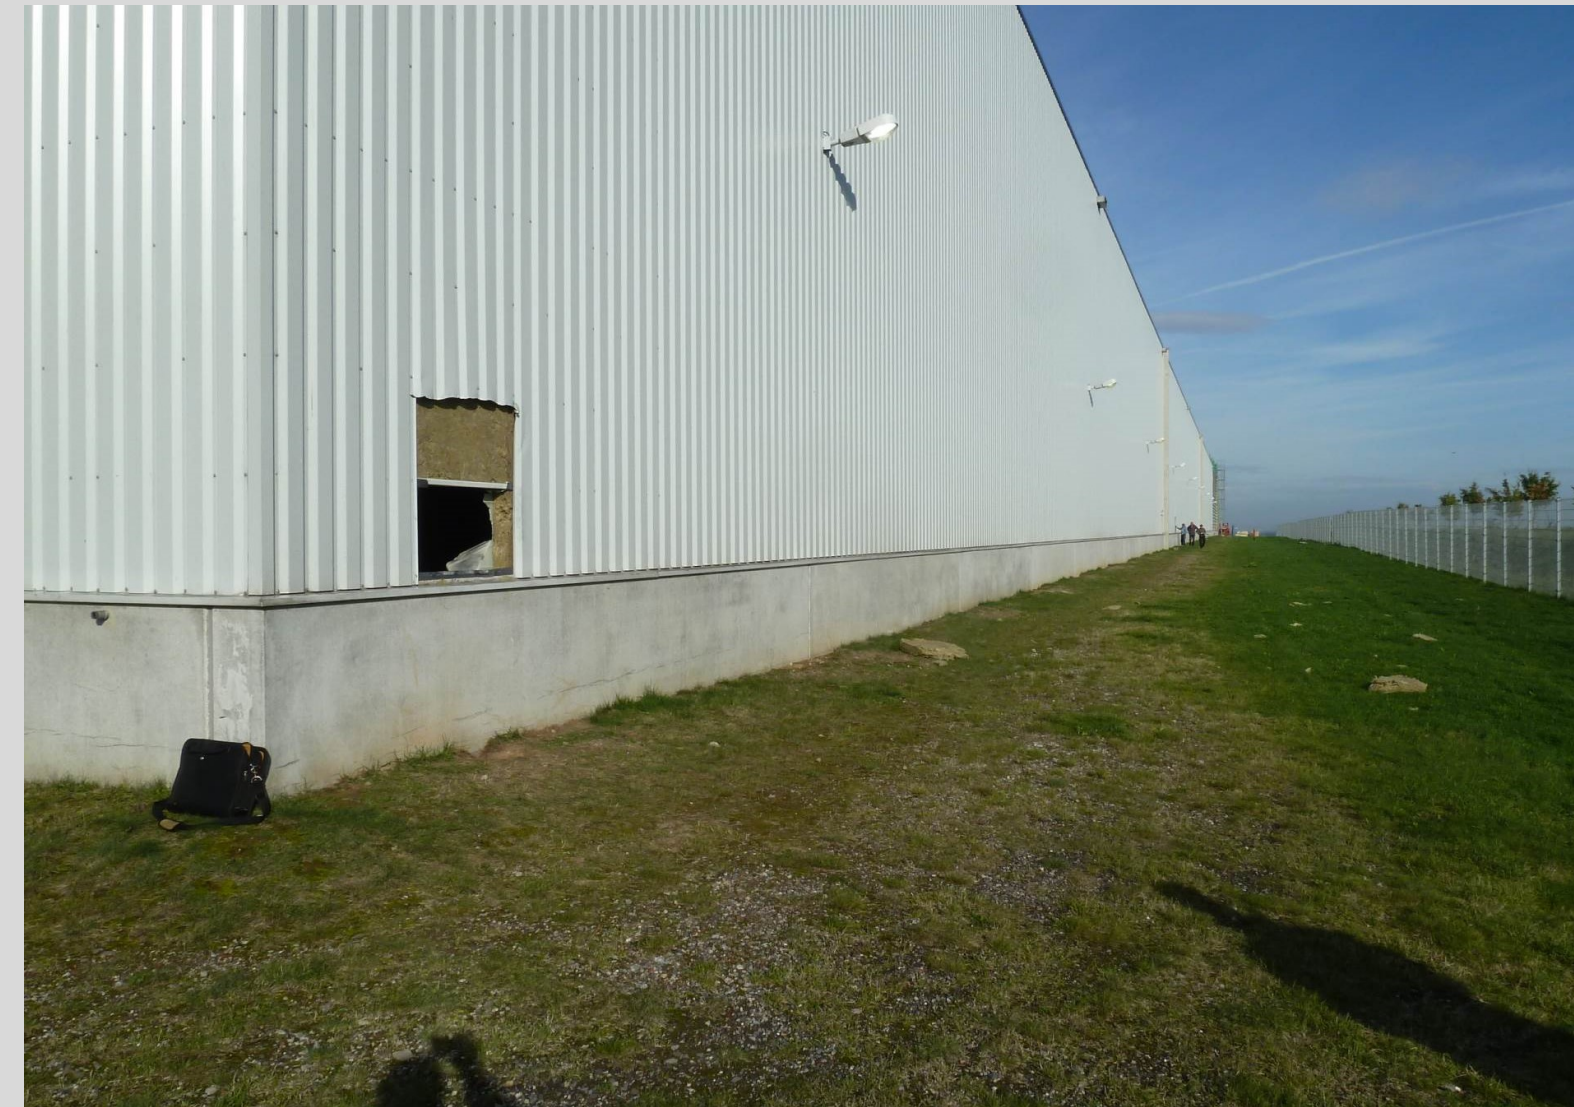
Photo 2: Closer view of outer wall

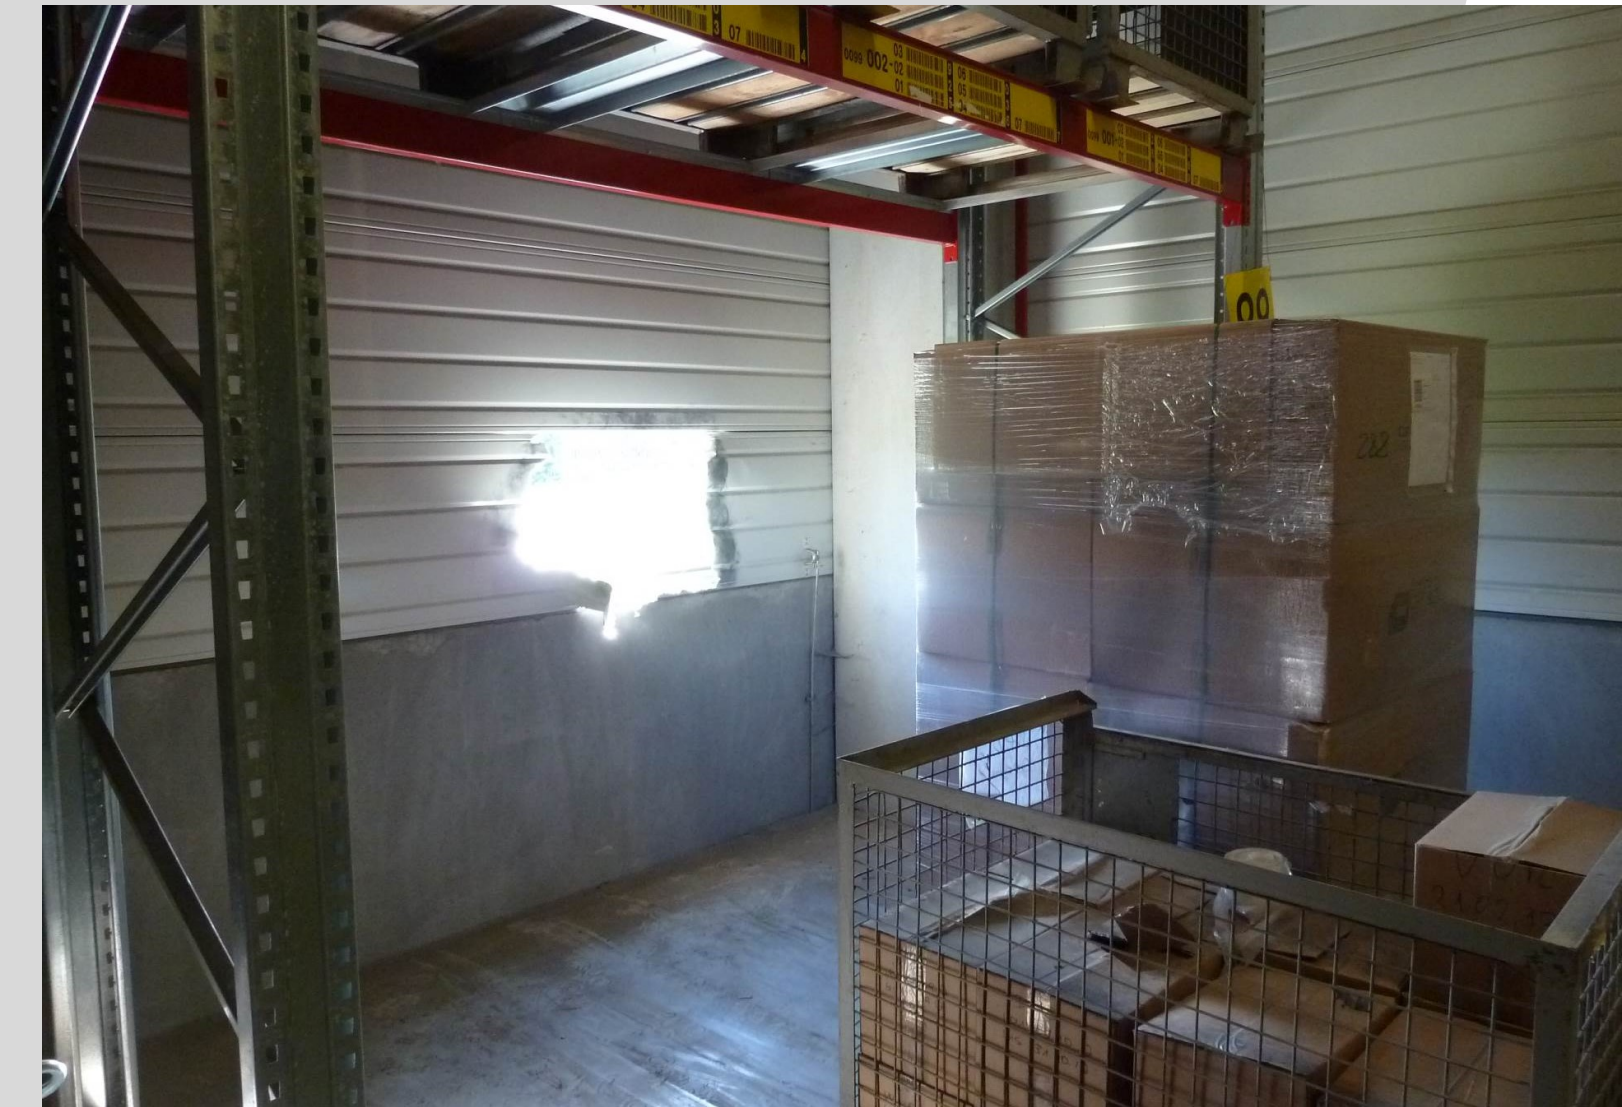
Photo 3: Inside view

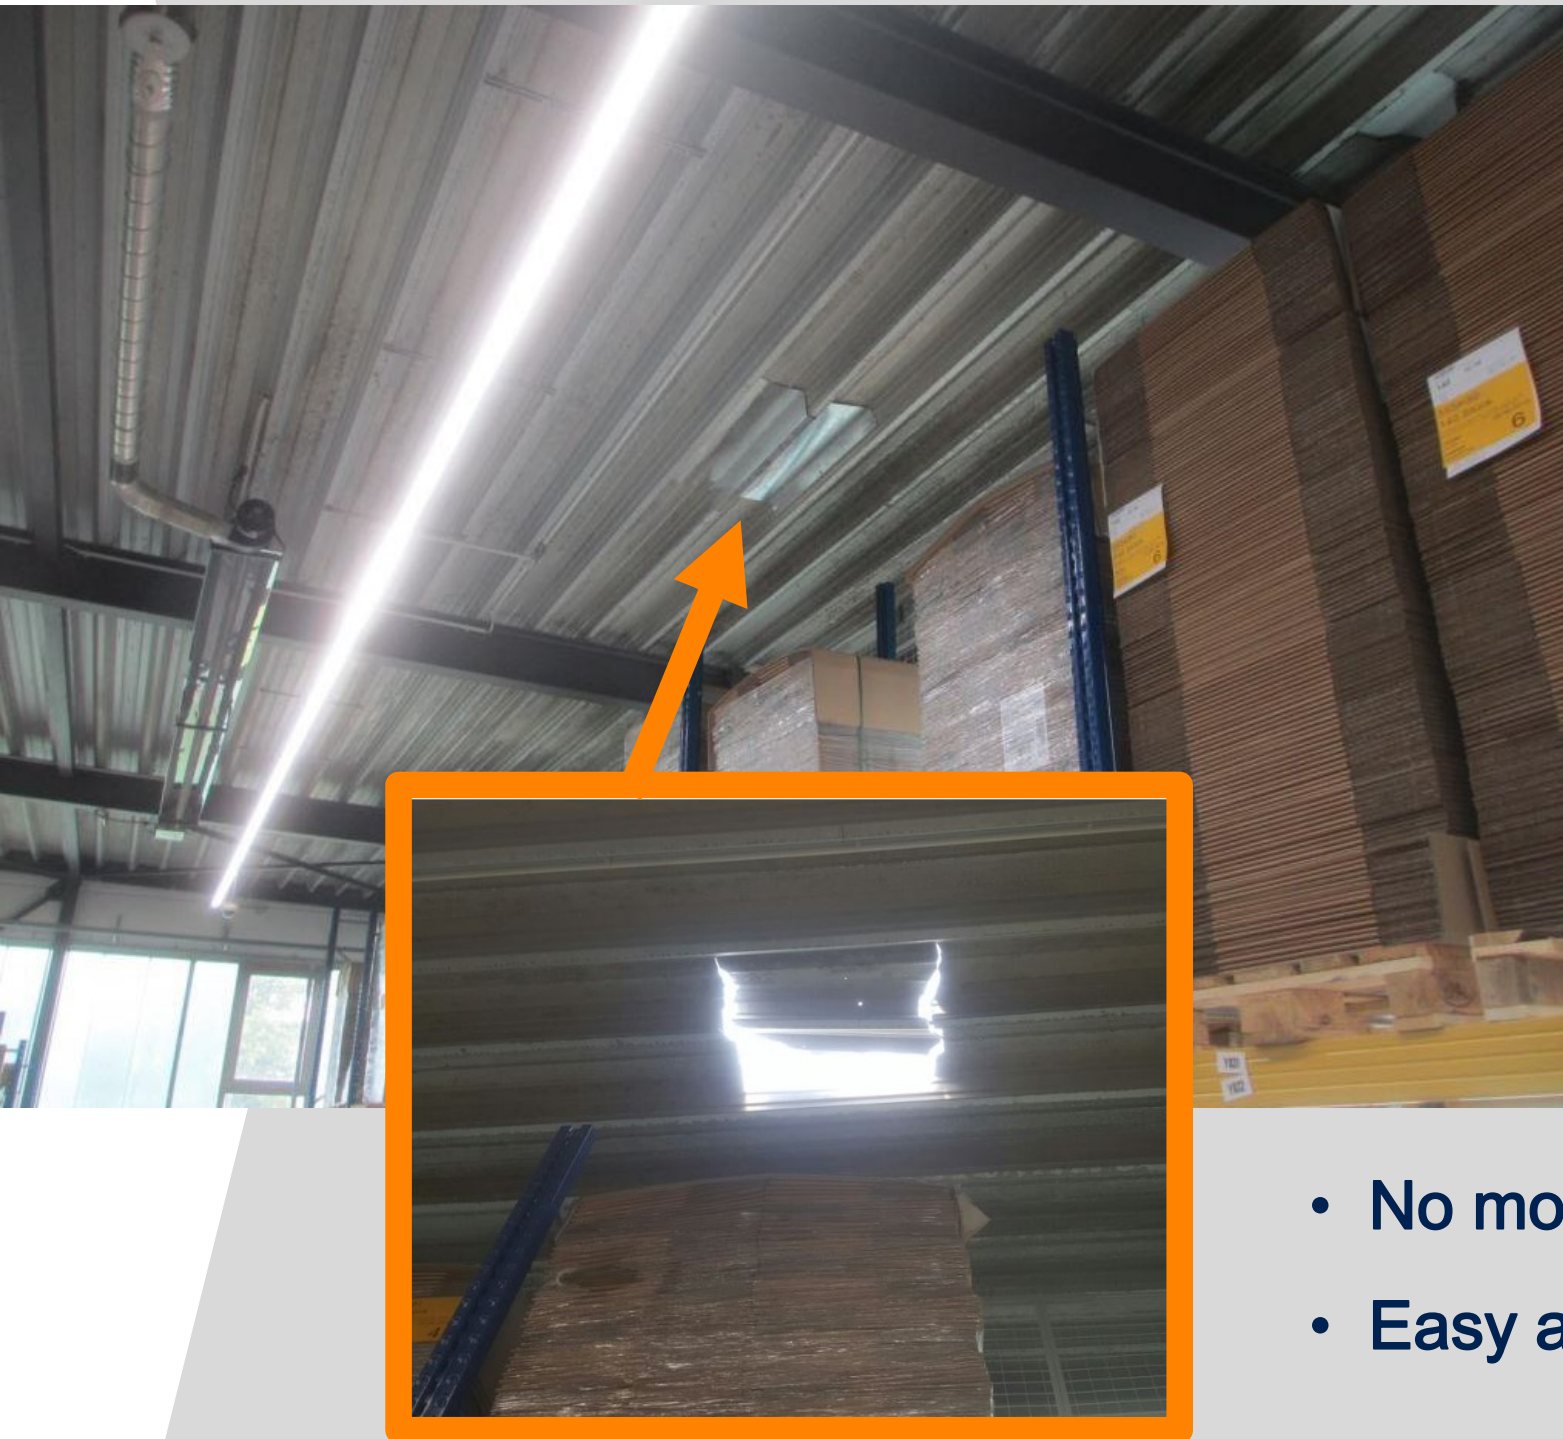
Photo 1: Roof was cut open

- No motion detectors inside the warehouse
- Easy access to the outdoor area and the roof

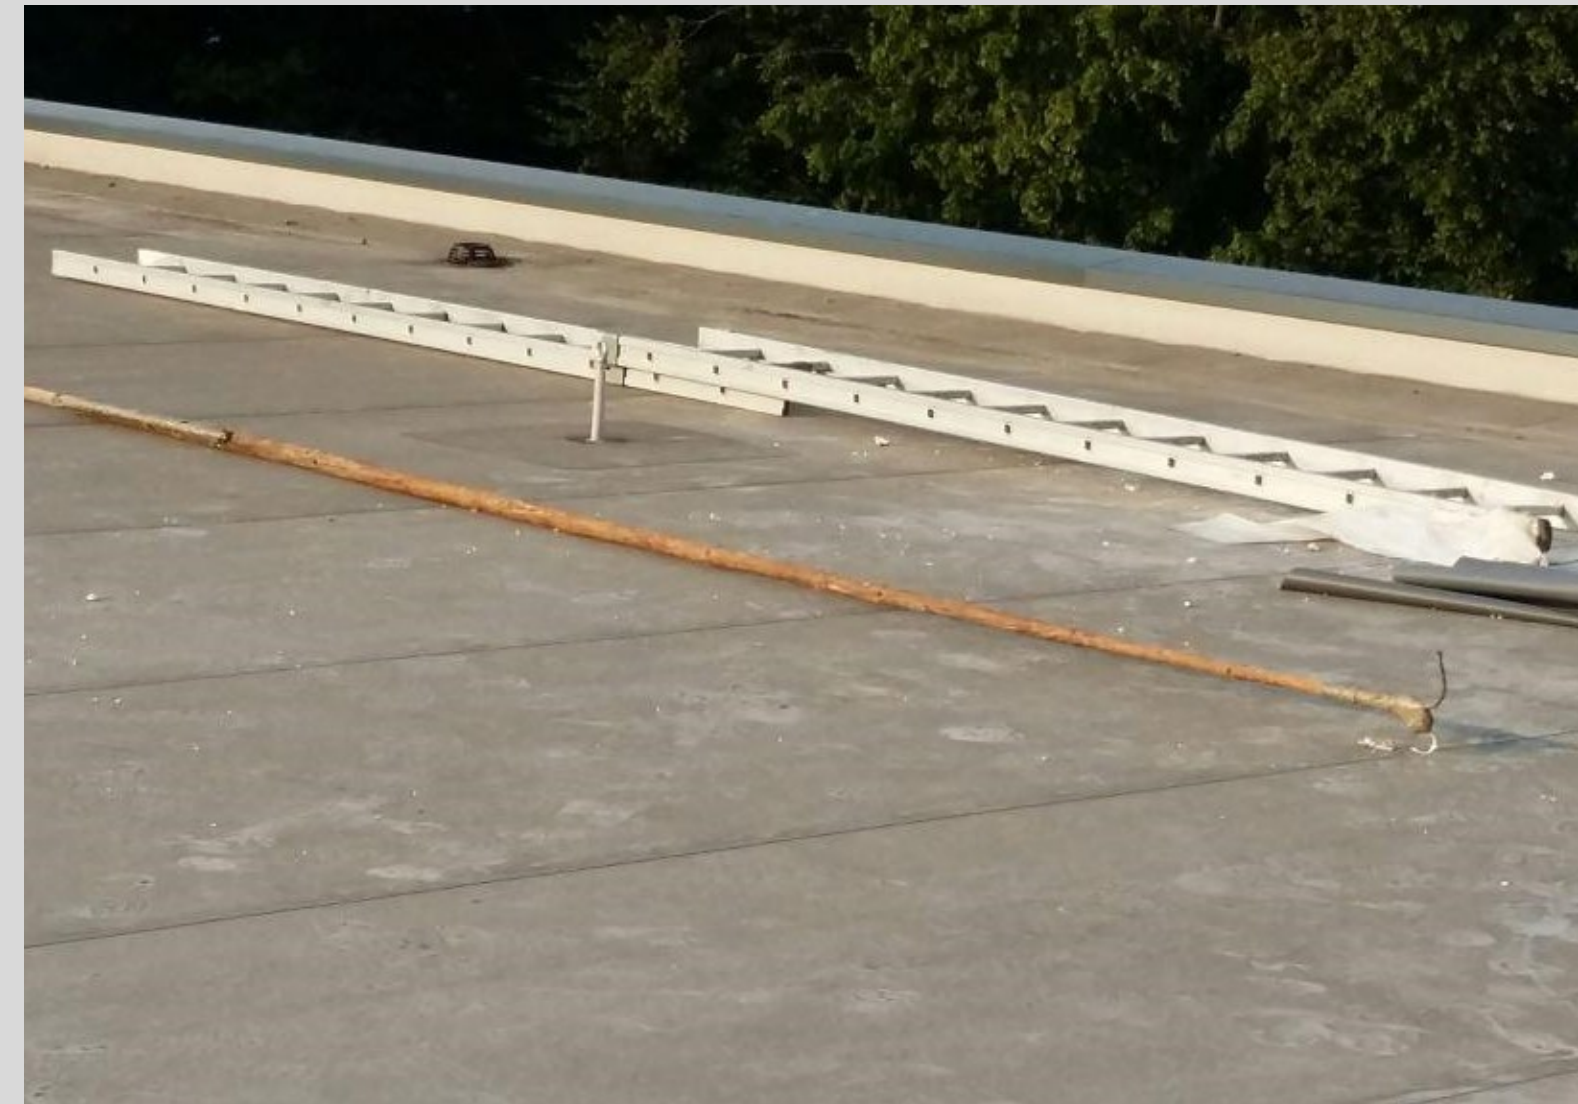
Photo 2: Ladder and Tools were left behind
