Static risks from the perspective of a cargo and warehouse surveyor

- less obvious risks -

Battermann & Tillery Global Marine GmbH

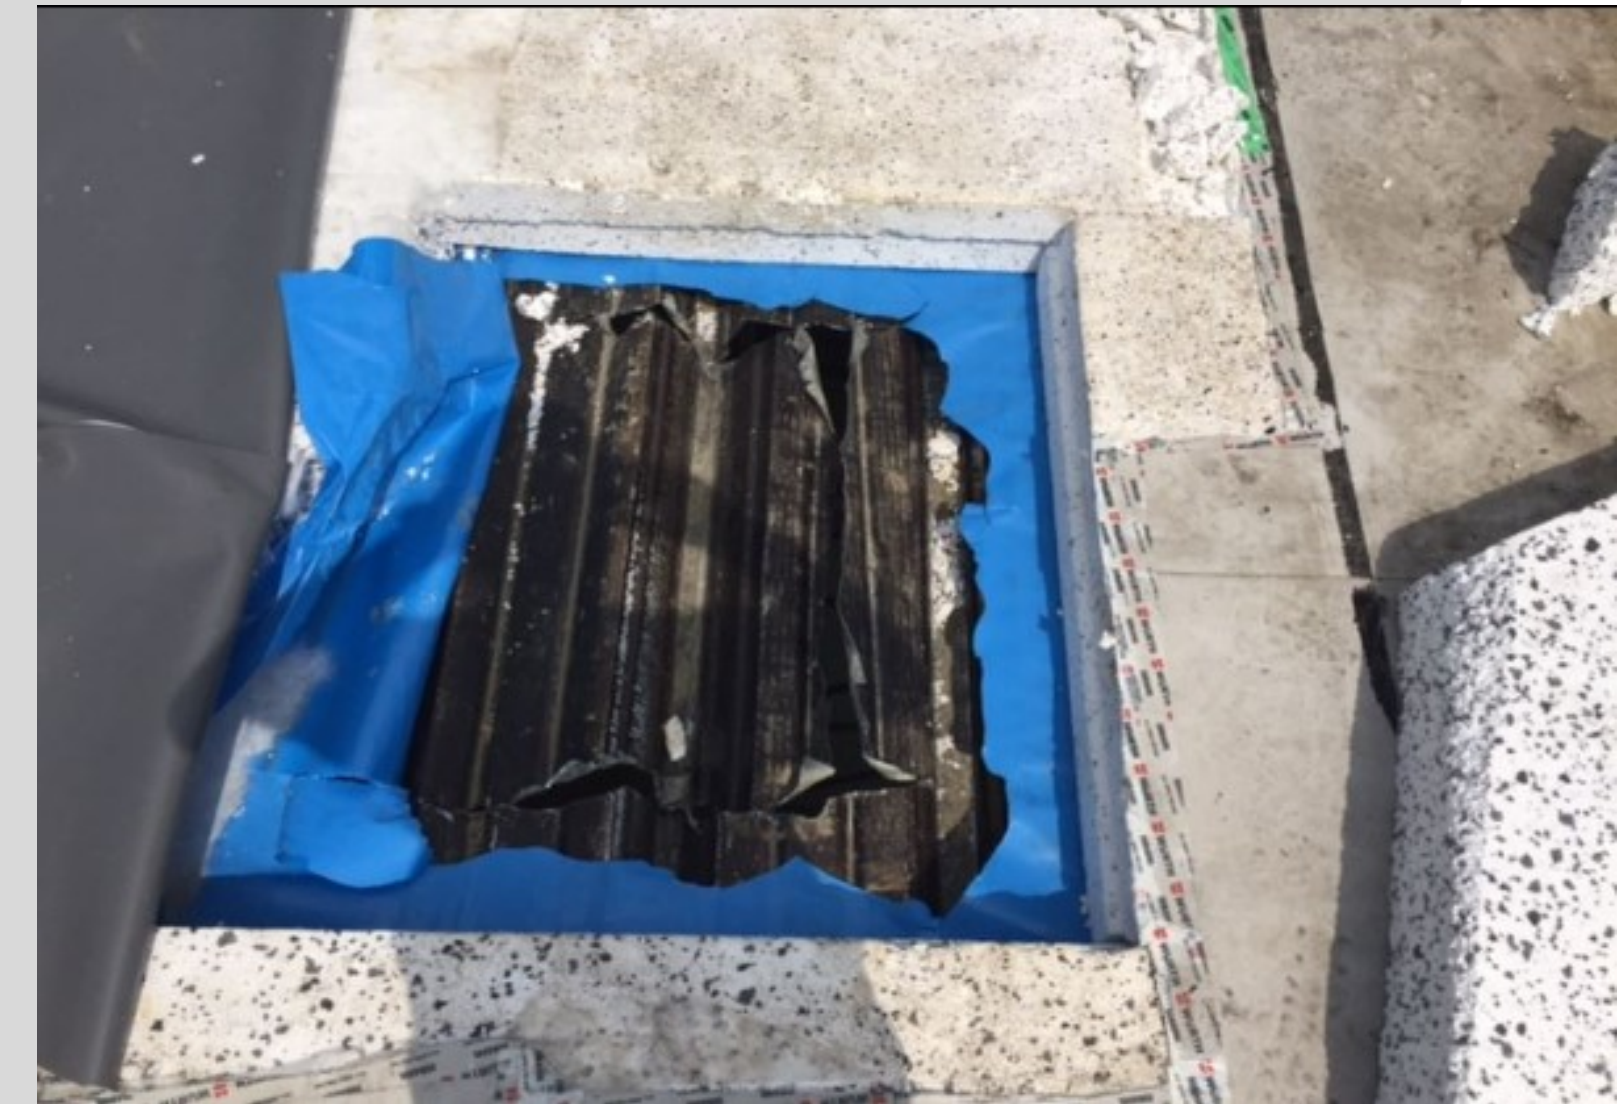
Photo 3: Ongoing repair at the time of survey

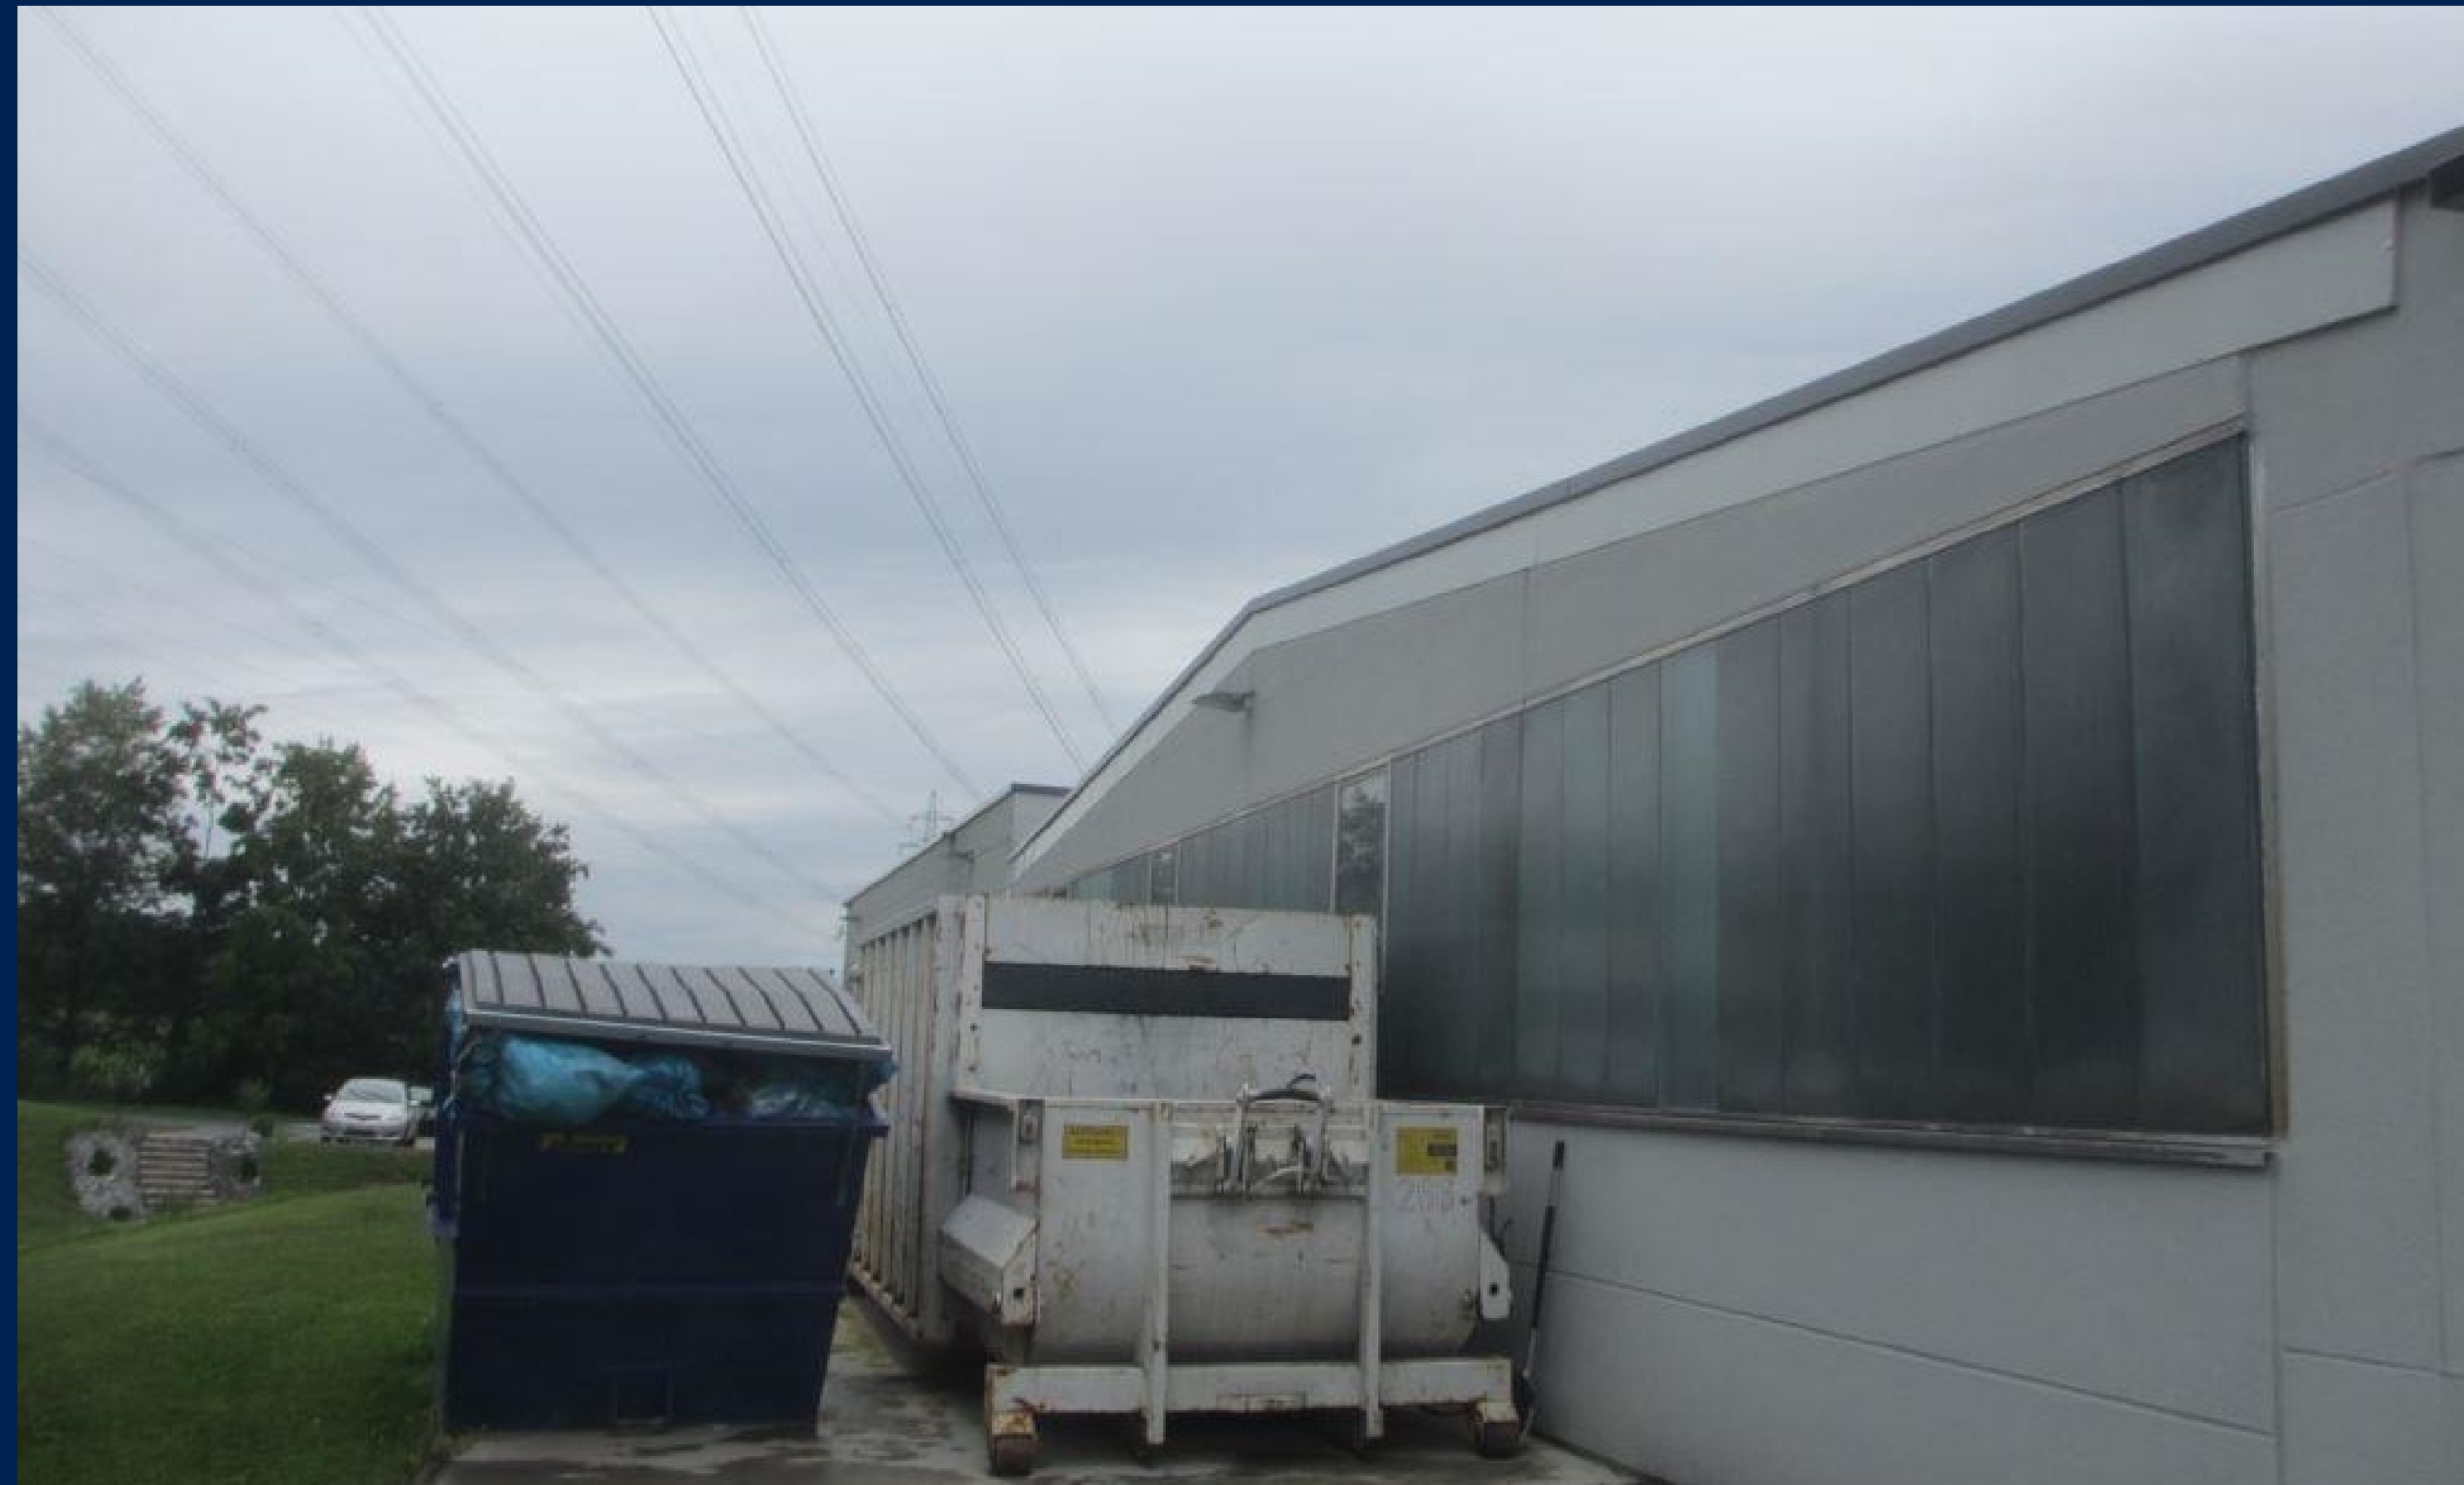
Waste containers positioned adjacent to the storage building not only increase the risk of fire. They also make it easier for perpetrators to gain roof access (and just as important - getting the stolen goods off the roof undamaged)

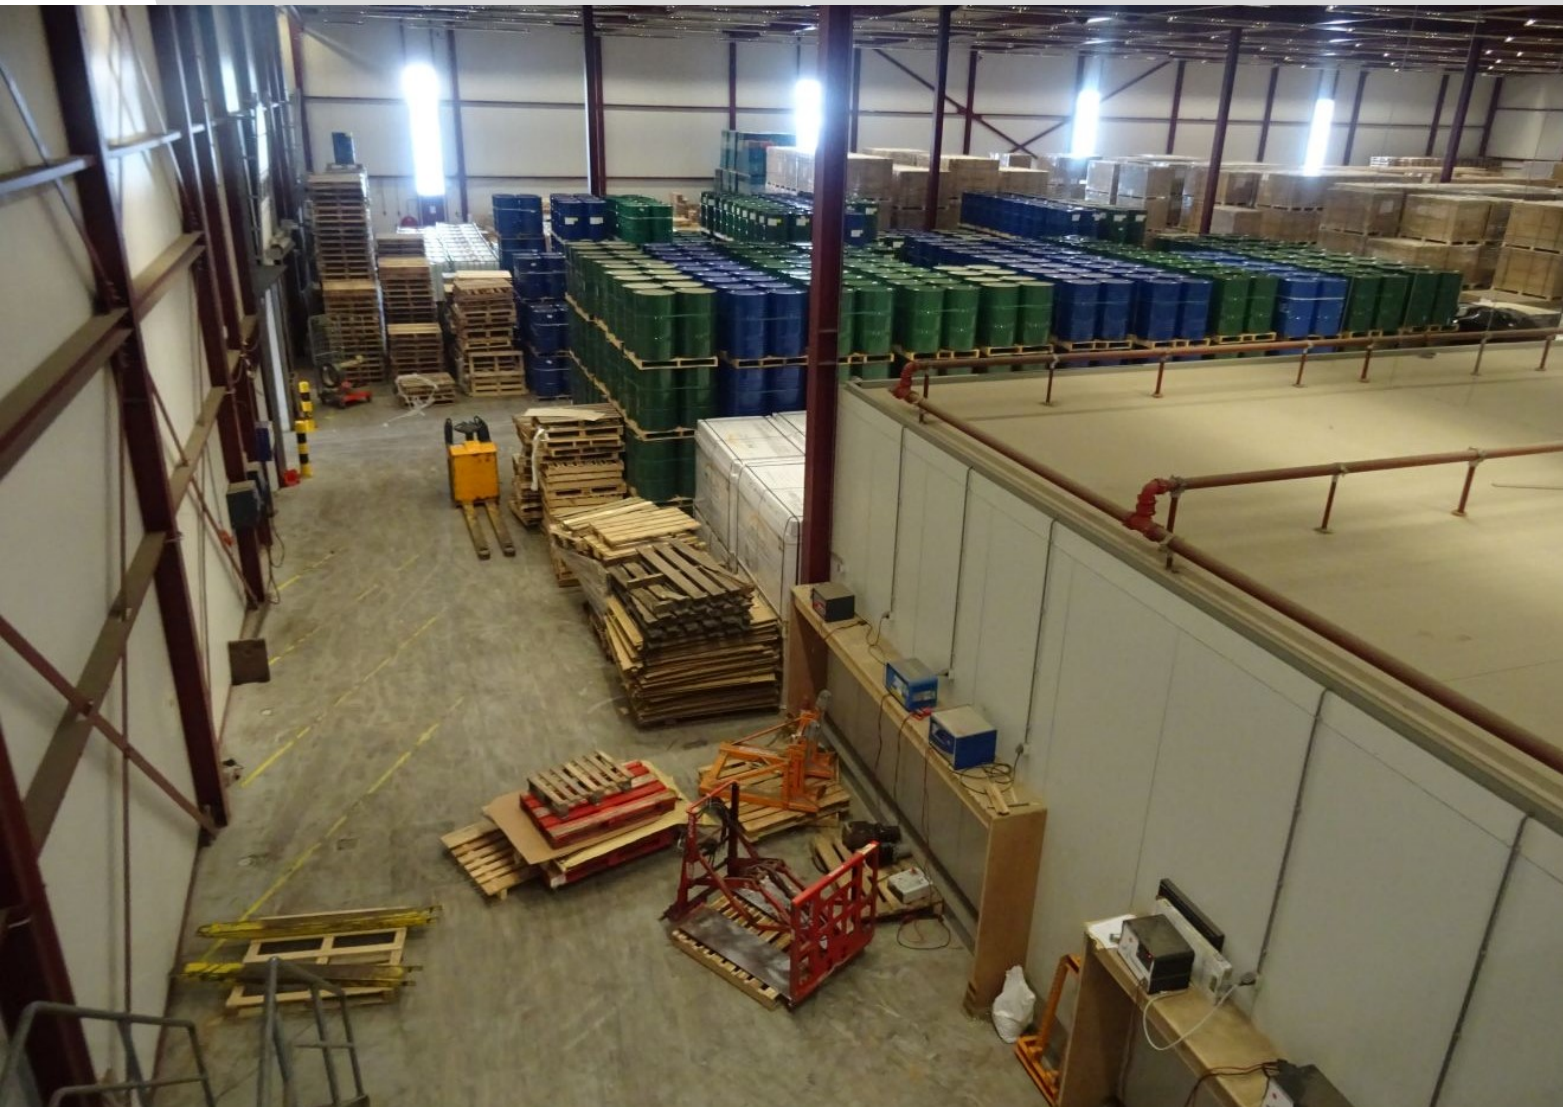
Photo 1: Fire loads and charging stations

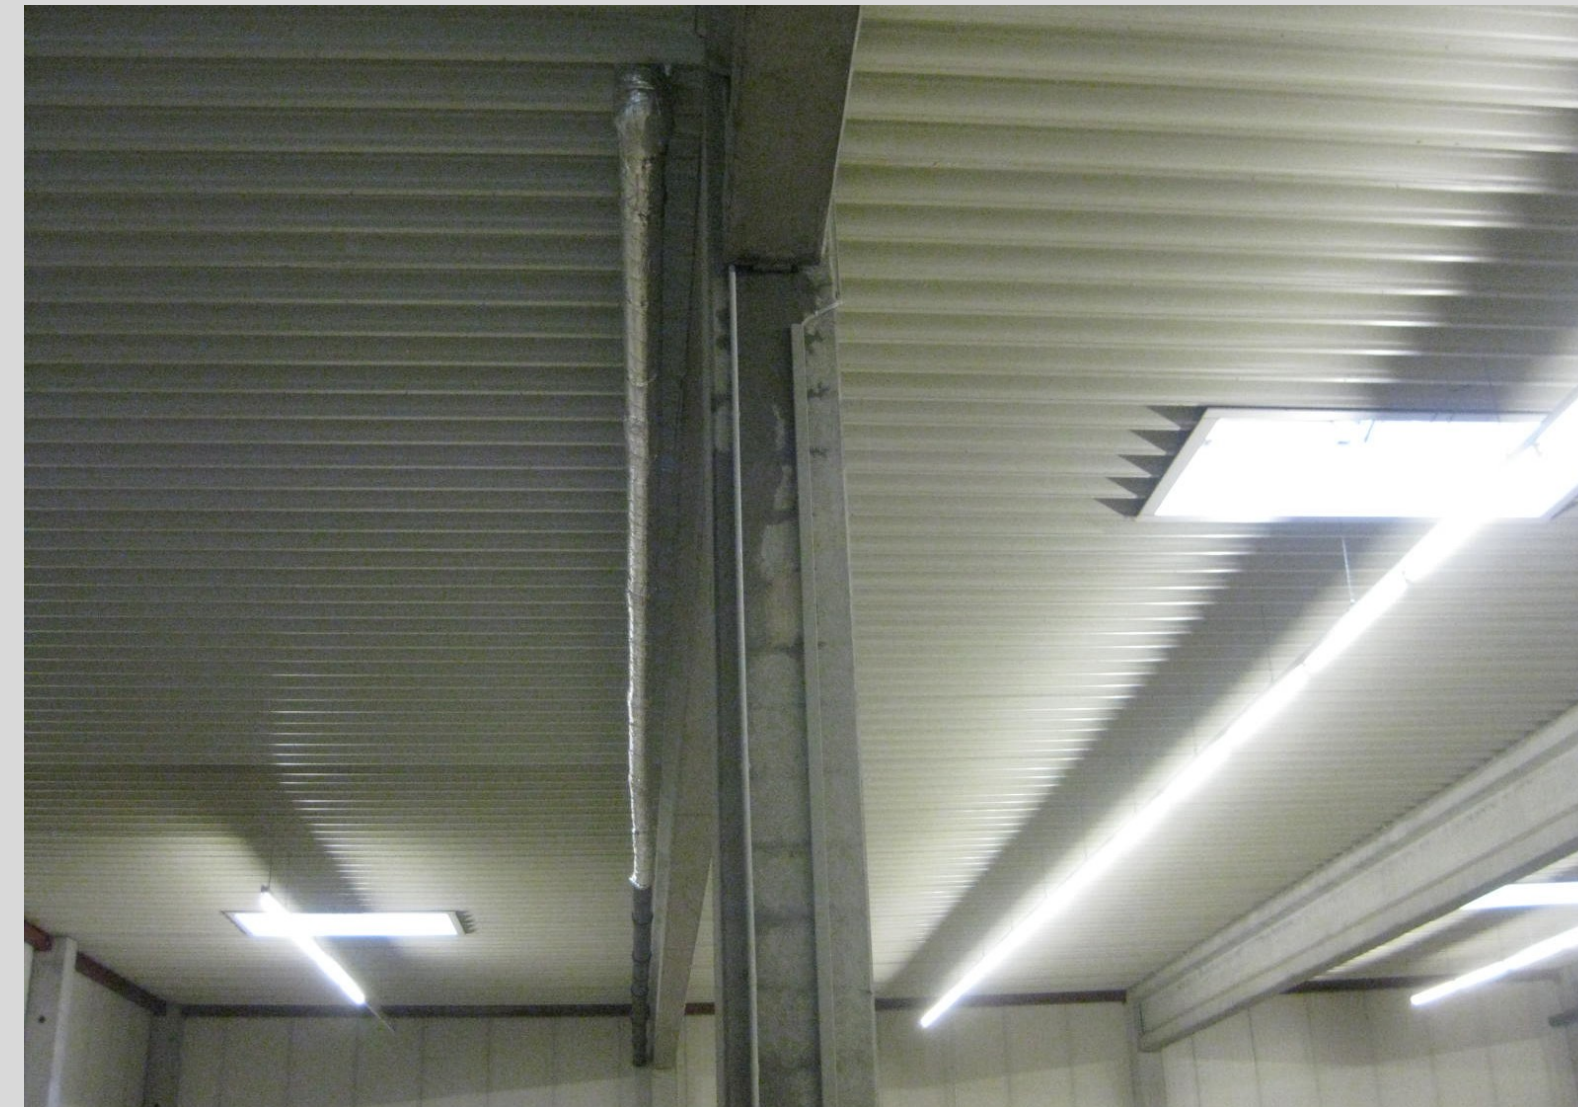
Photo 2: Horizontal PVC-downpipes

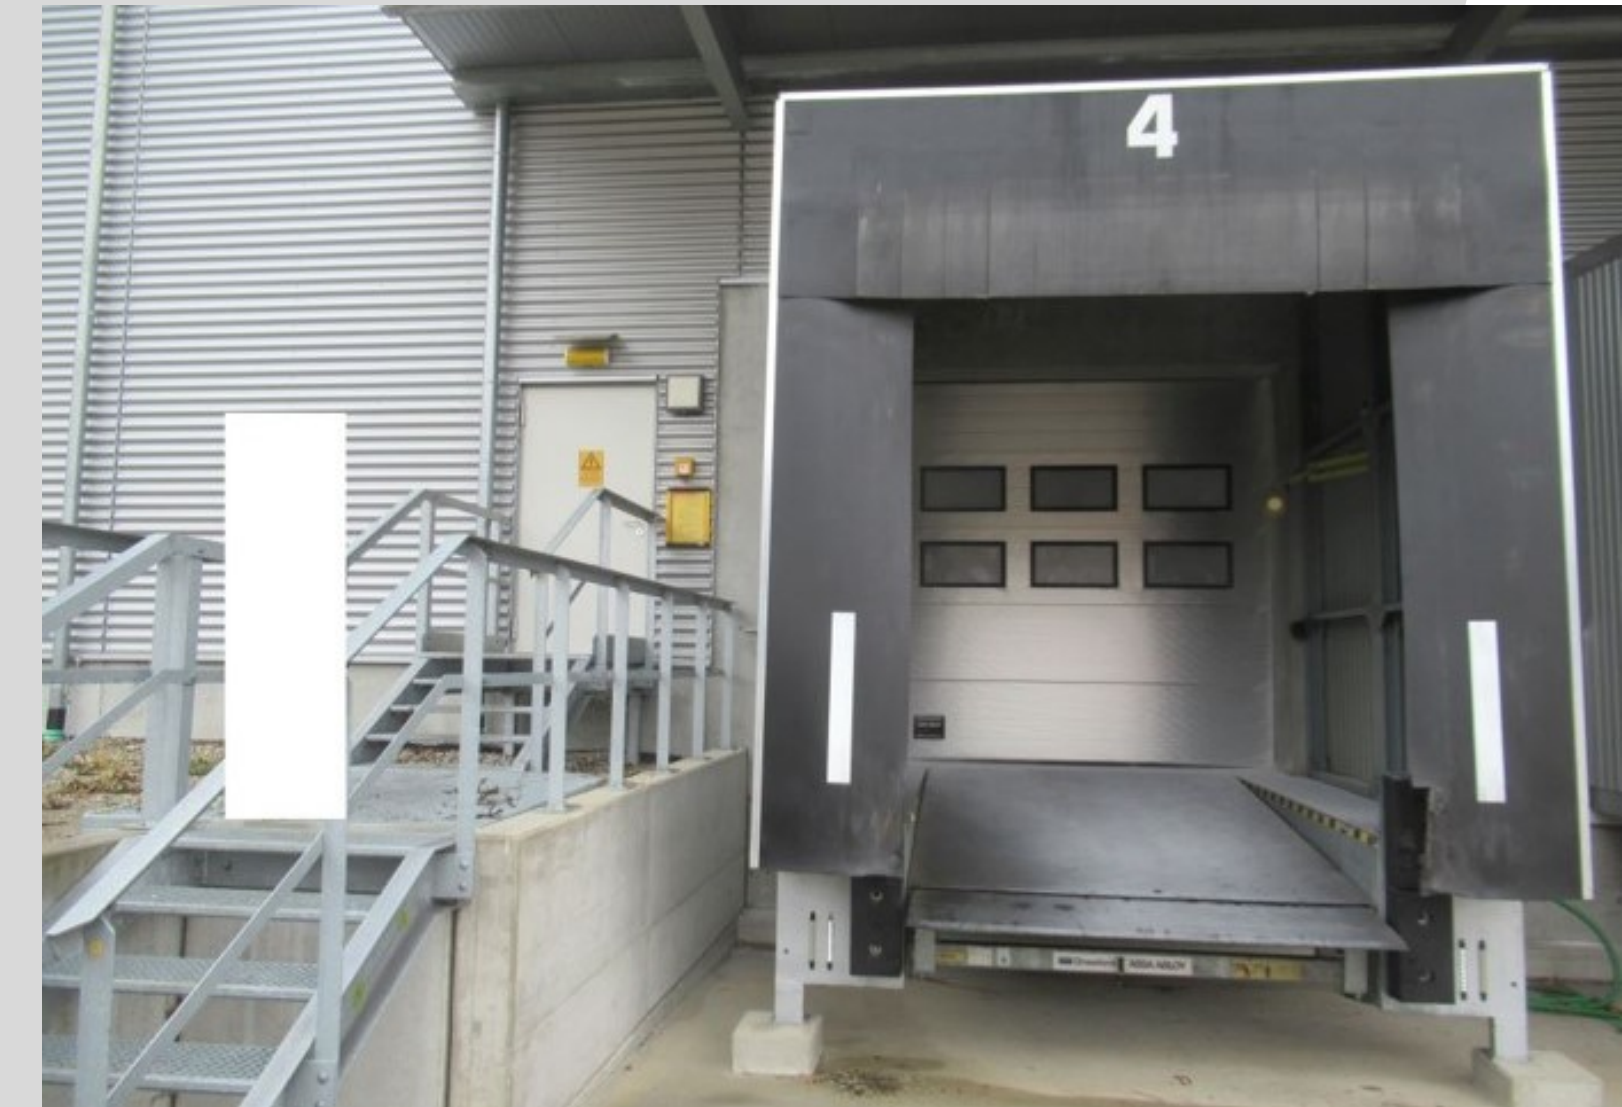
Photo 3: Switch positions
