Analysis of fires and firefighting operations on fully cellular container vessels over the period 2000 – 2015

Diploma dissertation

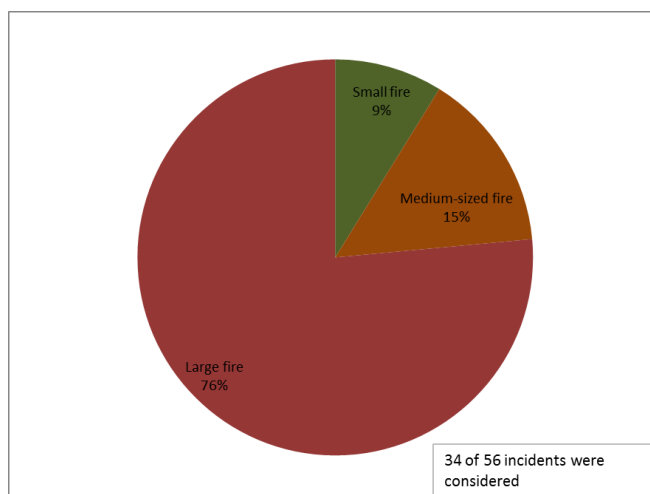
Figure 41, Extent of fires as per DIN 14010
 Source: Own presentation, source of data: List of incidents

As explained in the description of the procedures used, the extent of the fire was categorized using a version of the categories laid down in DIN 14010 and modified to apply to shipping. The extent of the fire was categorized for each case on the basis of the information available. The analysis shows that more than three quarters of the fires are to be classed as large fires and 15 % as medium-sized fires and that less than 10 % should be considered small fires.
